# KRUG ACTIVITY CENTER

## EXTERIOR HISTORIC REPAIRS

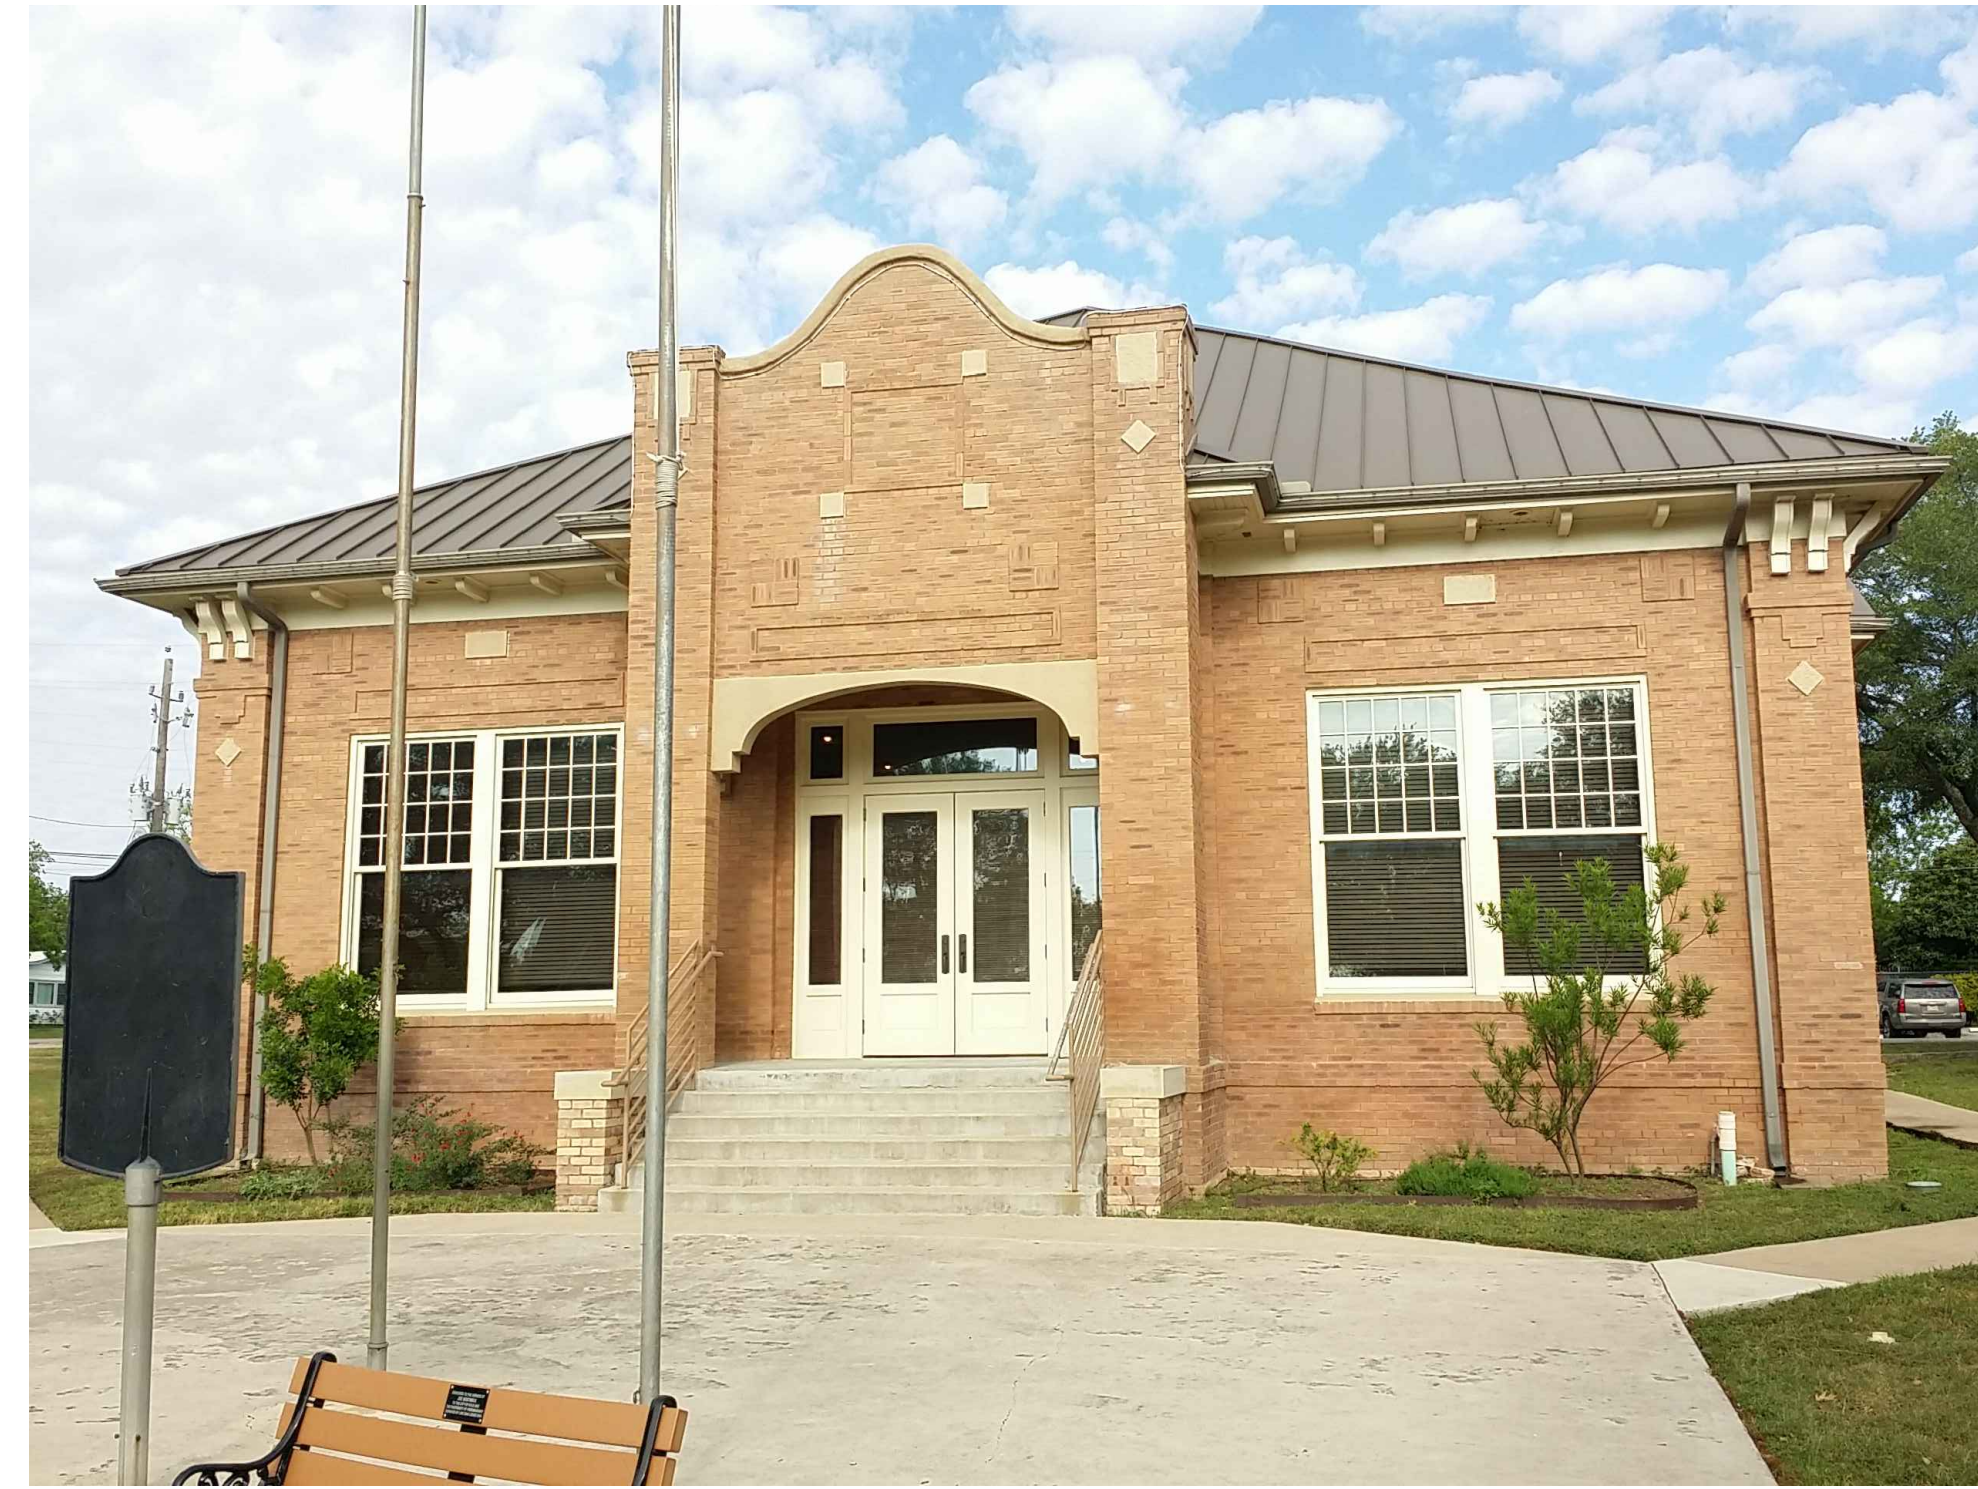
# CONTRACT DOCUMENTS

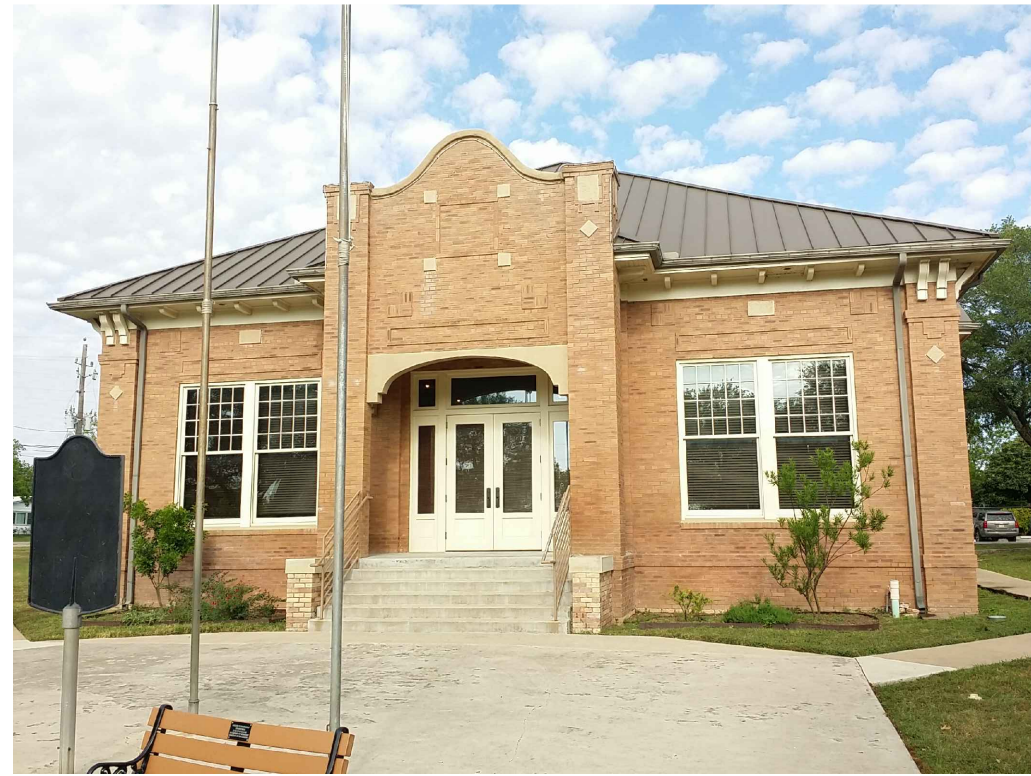
IMAGE 1: EAST ELEVATION: 1. EFFLORESCENCE WAS DETECTED AT THE BASE OF WALL THAT LIKELY OCCURRED DUE TO PROXIMITY OF SPRINKLERS. 2. PILASTER BRICK AND MASONRY CAP DISPLAYED SIGNIFICANT DAMAGE WITH OPEN AND FAILING MORTAR JOINTS. 3. WOOD SOFFITS ARE SAGGING AND IN SOME INSTANCES PULLING AWAY FROM ADJOINING STRUCTURE.

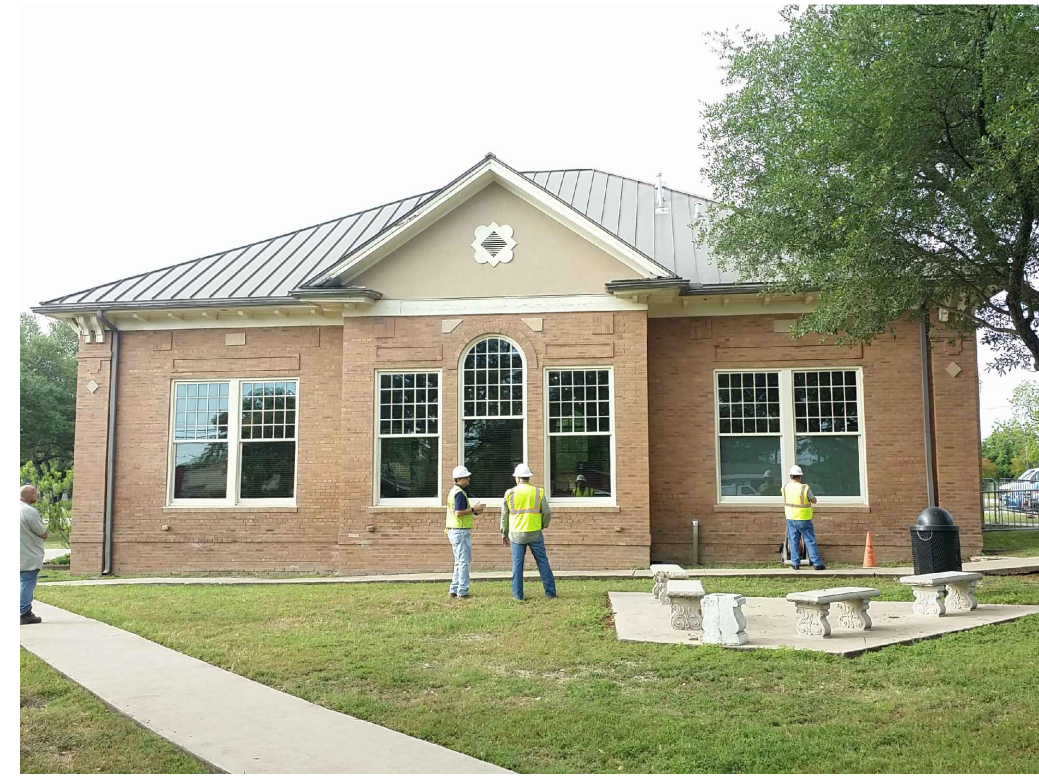
IMAGE 2: NORTH ELEVATION: 1. EFFLORESCENCE WAS DETECTED AT THE BASE OF WALL THAT LIKELY OCCURRED DUE TO PROXIMITY OF SPRINKLERS. 2. WOOD SOFFITS ARE SAGGING AND IN SOME INSTANCES PULLING AWAY FROM ADJOINING STRUCTURE. 3. DETERIORATION OF WOOD FASCIA. 4. DETERIORATION OF FASCIA RESULTING IN LOCALIZED SEPARATION OF THE GUTTER ASSEMBLY.

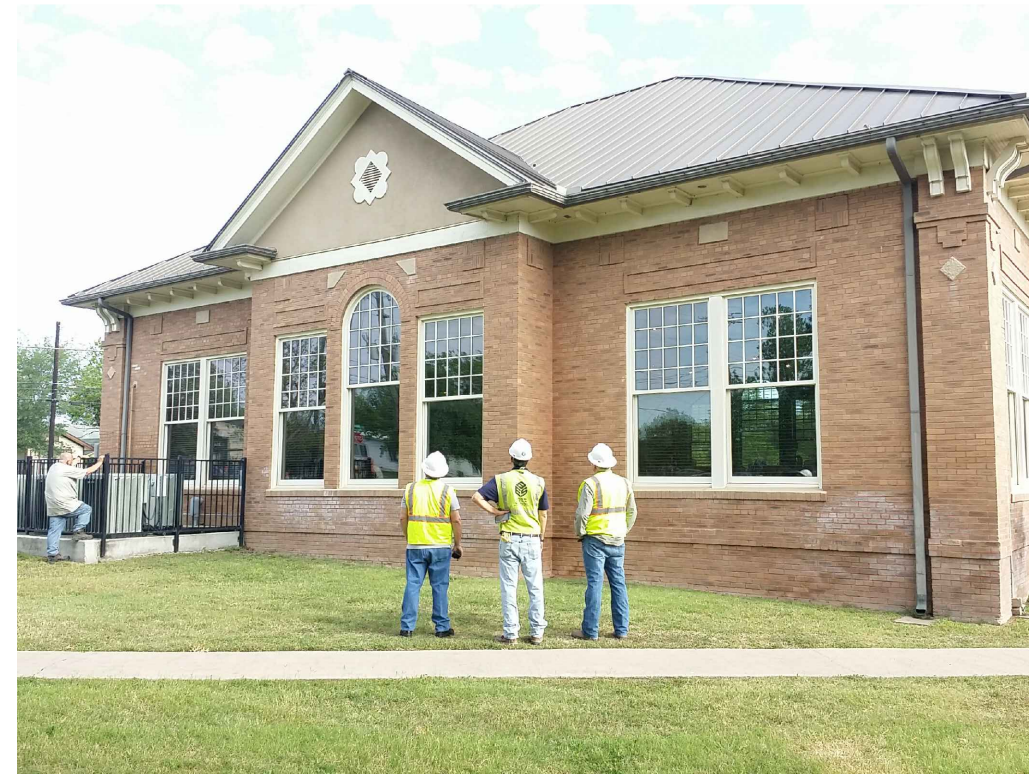
IMAGE 3: SOUTH ELEVATION: 1. EFFLORESCENCE WAS DETECTED AT THE BASE OF WALL THAT LIKELY OCCURRED DUE TO PROXIMITY OF SPRINKLERS. 2. WOOD SOFFITS ARE SAGGING AND IN SOME INSTANCES PULLING AWAY FROM ADJOINING STRUCTURE. 3. DETERIORATION OF WOOD FASCIA. 4. DETERIORATION OF FASCIA RESULTING IN LOCALIZED SEPARATION OF THE GUTTER ASSEMBLY.

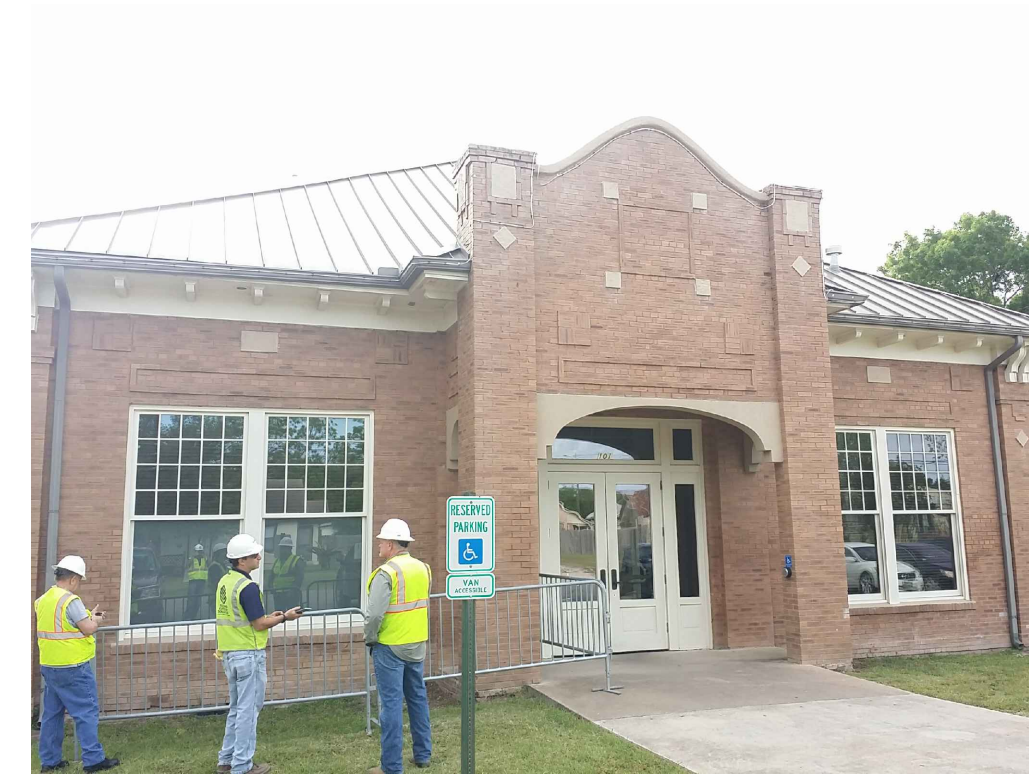
IMAGE 4: WEST ELEVATION: 1. EFFLORESCENCE WAS DETECTED AT THE BASE OF WALL THAT LIKELY OCCURRED DUE TO PROXIMITY OF SPRINKLERS. 2. PILASTER BRICK AND MASONRY CAP DISPLAYED SIGNIFICANT DAMAGE WITH OPEN AND FAILING MORTAR JOINTS. 3. WOOD SOFFITS ARE SAGGING AND IN SOME INSTANCES PULLING AWAY FROM ADJOINING STRUCTURE.

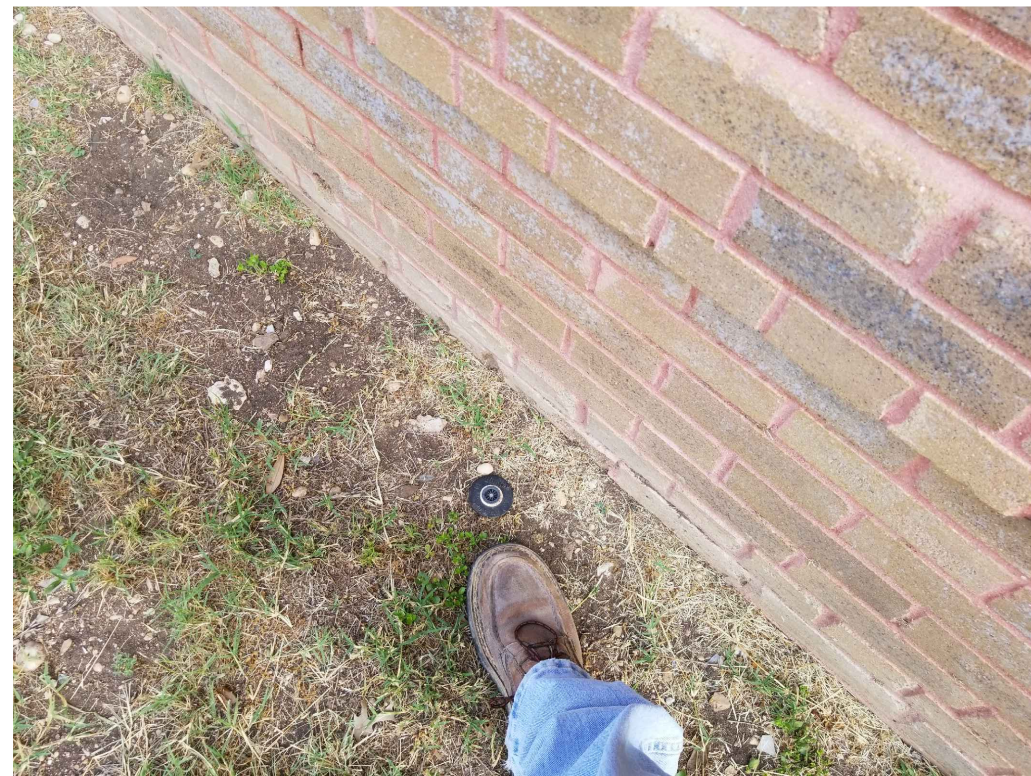
IMAGE 5: SPRINKLER HEAD: 1. EFFLORESCENCE WAS DETECTED AT THE BASE OF WALL THAT LIKELY OCCURRED DUE TO PROXIMITY OF SPRINKLERS.

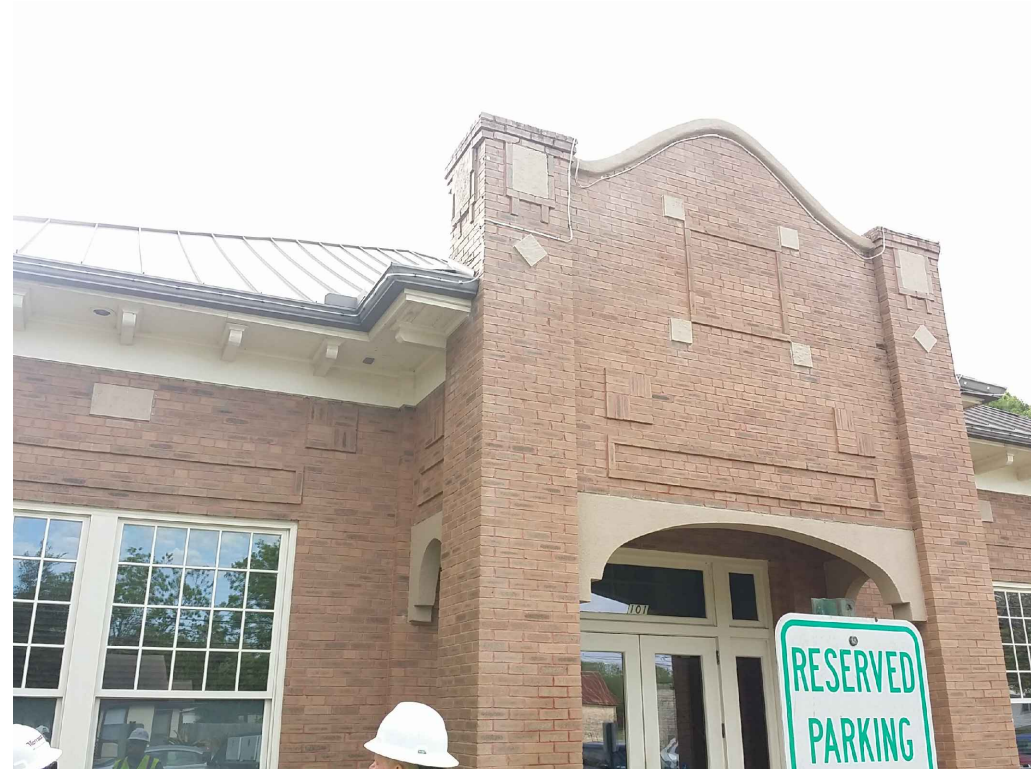
IMAGE 9: WEST ELEVATION: 1. PILASTER BRICK AND MASONRY CAP DISPLAYED SIGNIFICANT DAMAGE WITH OPEN AND FAILING MORTAR JOINTS. 2. WOOD SOFFITS ARE SAGGING AND IN SOME INSTANCES PULLING AWAY FROM ADJOINING STRUCTURE.

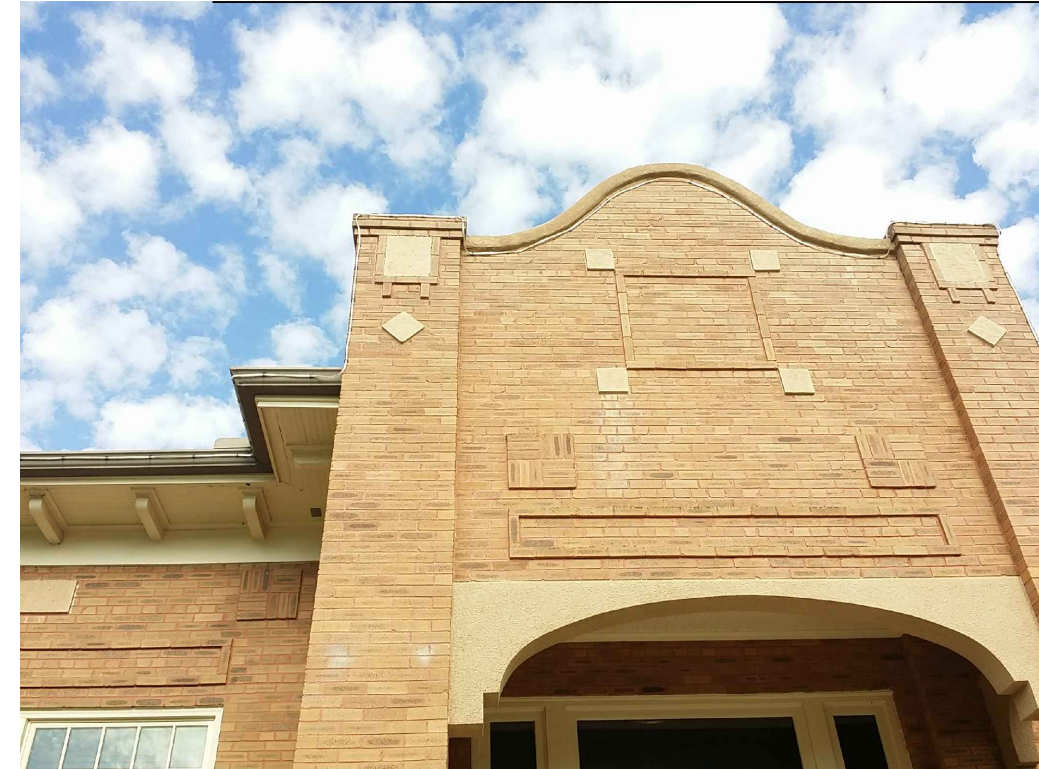
IMAGE 10: EAST ELEVATION: 1. PILASTER BRICK AND MASONRY CAP DISPLAYED SIGNIFICANT DAMAGE WITH OPEN AND FAILING MORTAR JOINTS. 2. WOOD SOFFITS ARE SAGGING AND IN SOME INSTANCES PULLING AWAY FROM ADJOINING STRUCTURE.

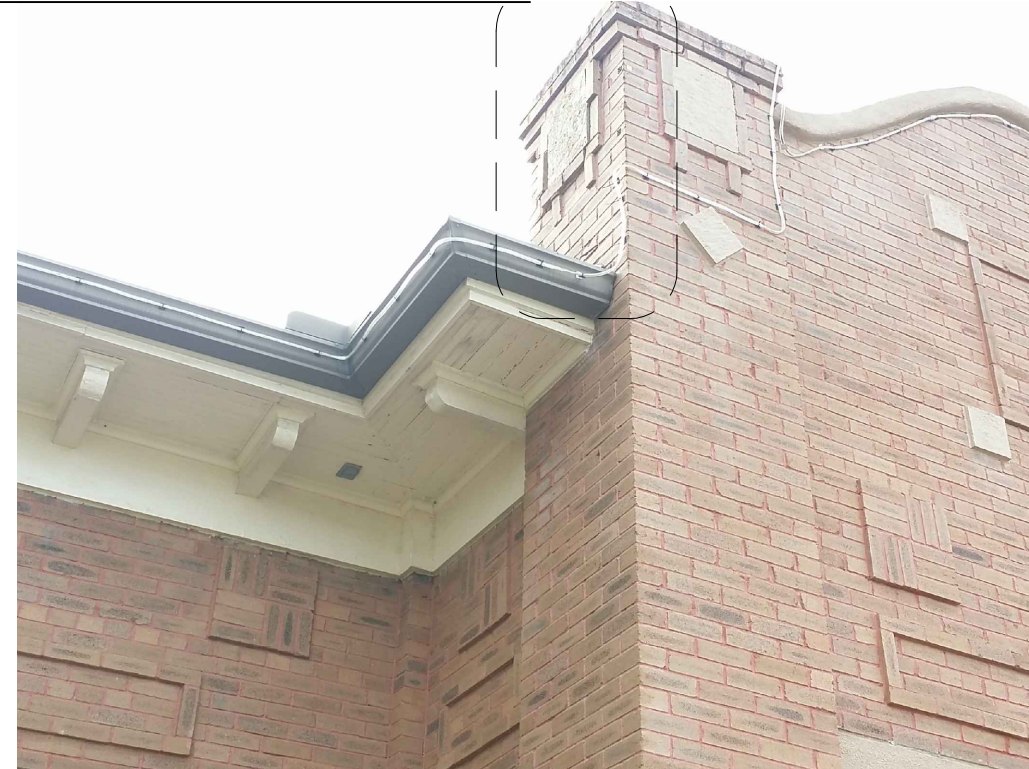
IMAGE 11: WEST ELEVATION: 1. PILASTER BRICK AND MASONRY CAP DISPLAYED SIGNIFICANT DAMAGE WITH OPEN AND FAILING MORTAR JOINTS. 2. WOOD SOFFITS ARE SAGGING AND IN SOME INSTANCES PULLING AWAY FROM ADJOINING STRUCTURE.

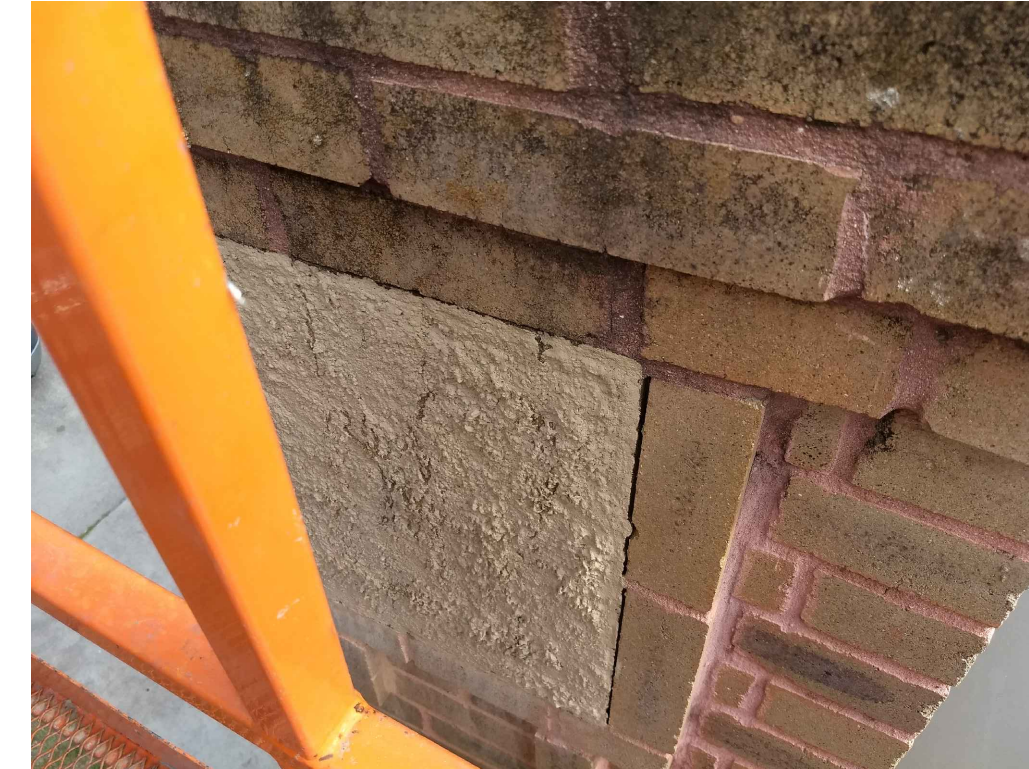
IMAGE 12: TYPICAL STUCCO TO BRICK TRANSITION: SEPARATION AT JOINT BETWEEN STUCCO AND BRICK.

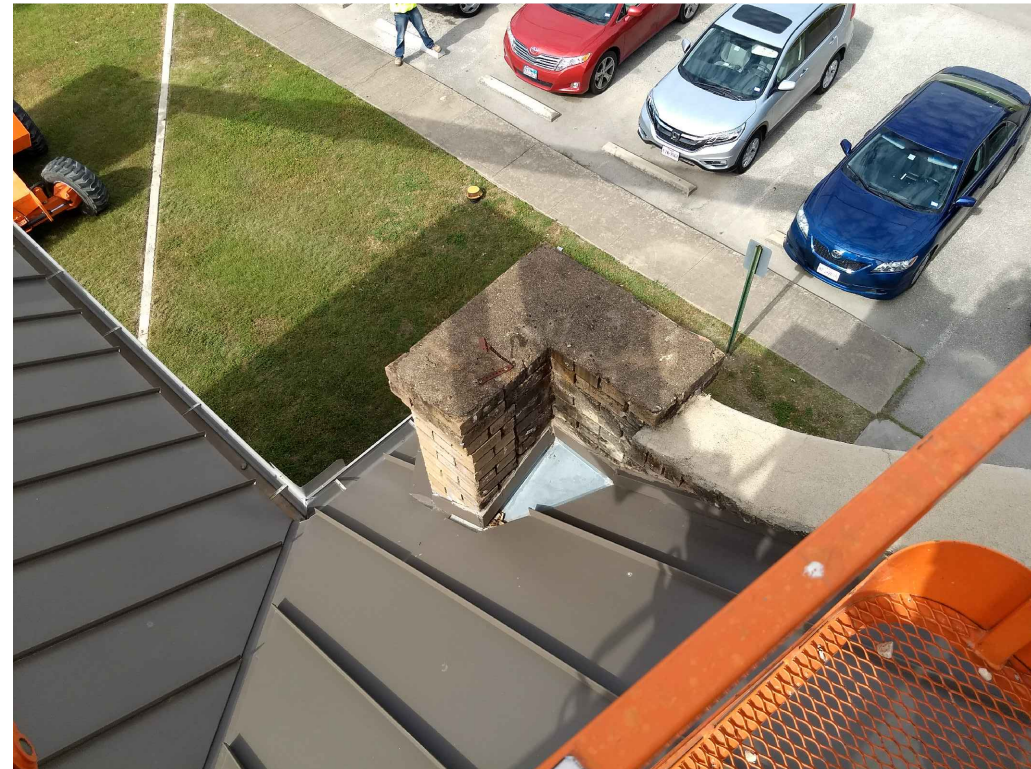
IMAGE 13: NORTH WEST MASONRY PILASTER: 1. PILASTER BRICK AND MASONRY CAP DISPLAYED SIGNIFICANT DAMAGE WITH OPEN AND FAILING MORTAR JOINTS.

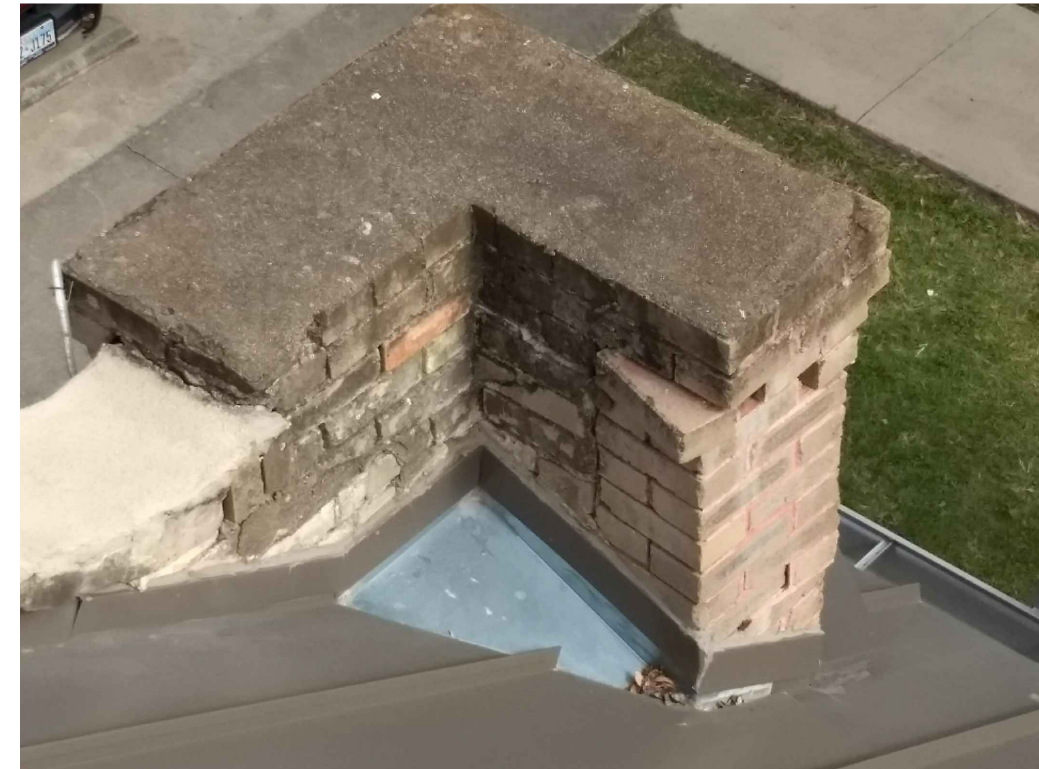
IMAGE 14: SOUTH WEST MASONRY PILASTER: 1. PILASTER BRICK AND MASONRY CAP DISPLAYED SIGNIFICANT DAMAGE WITH OPEN AND FAILING MORTAR JOINTS.

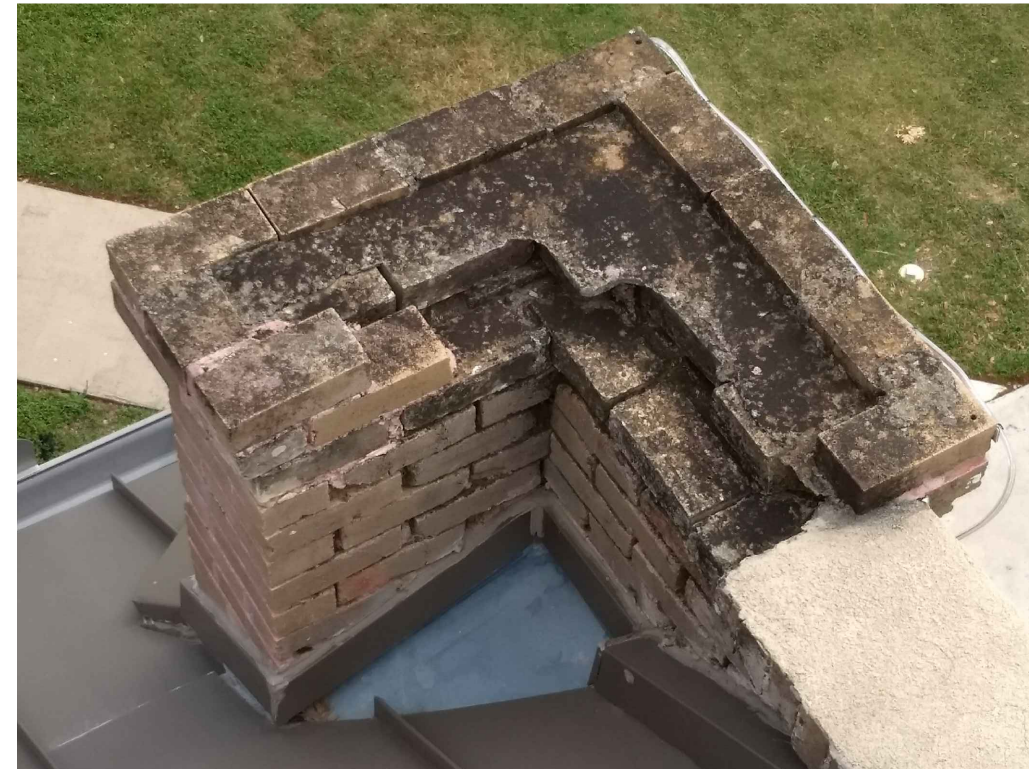
IMAGE 15: NORTH EAST MASONRY PILASTER: 1. PILASTER BRICK AND MASONRY CAP DISPLAYED SIGNIFICANT DAMAGE WITH OPEN AND FAILING MORTAR JOINTS.

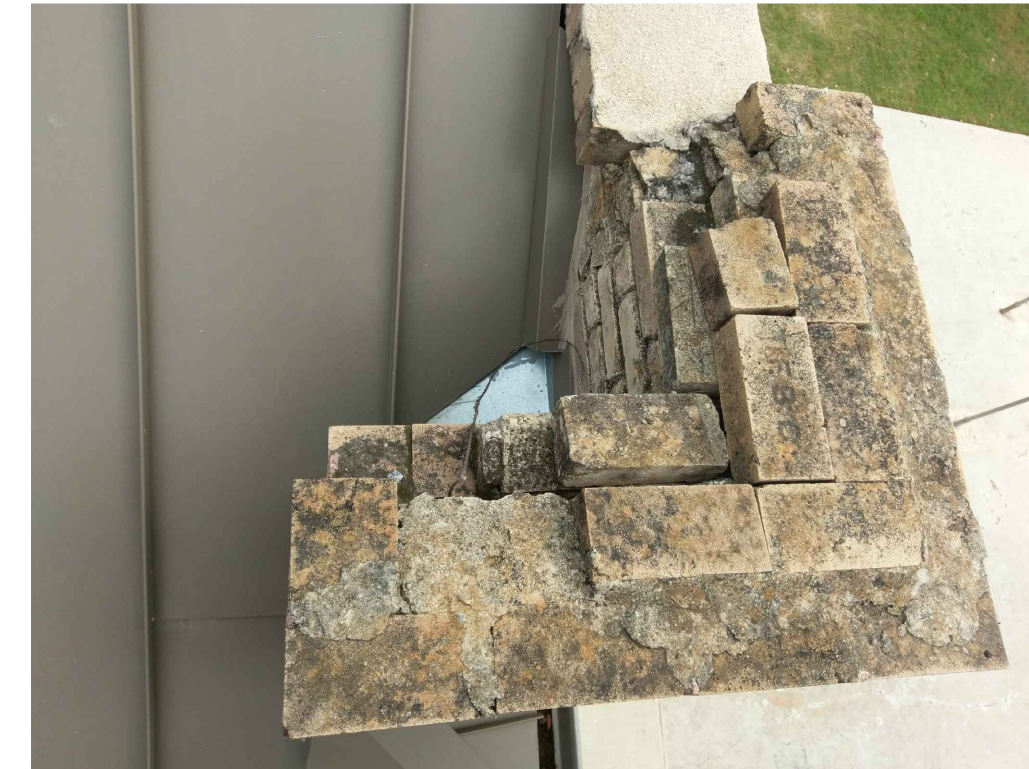
IMAGE 16: SOUTH EAST MASONRY PILASTER: 1. PILASTER BRICK AND MASONRY CAP DISPLAYED SIGNIFICANT DAMAGE WITH OPEN AND FAILING MORTAR JOINTS AND LOOSE SHIFTING BRICKS.

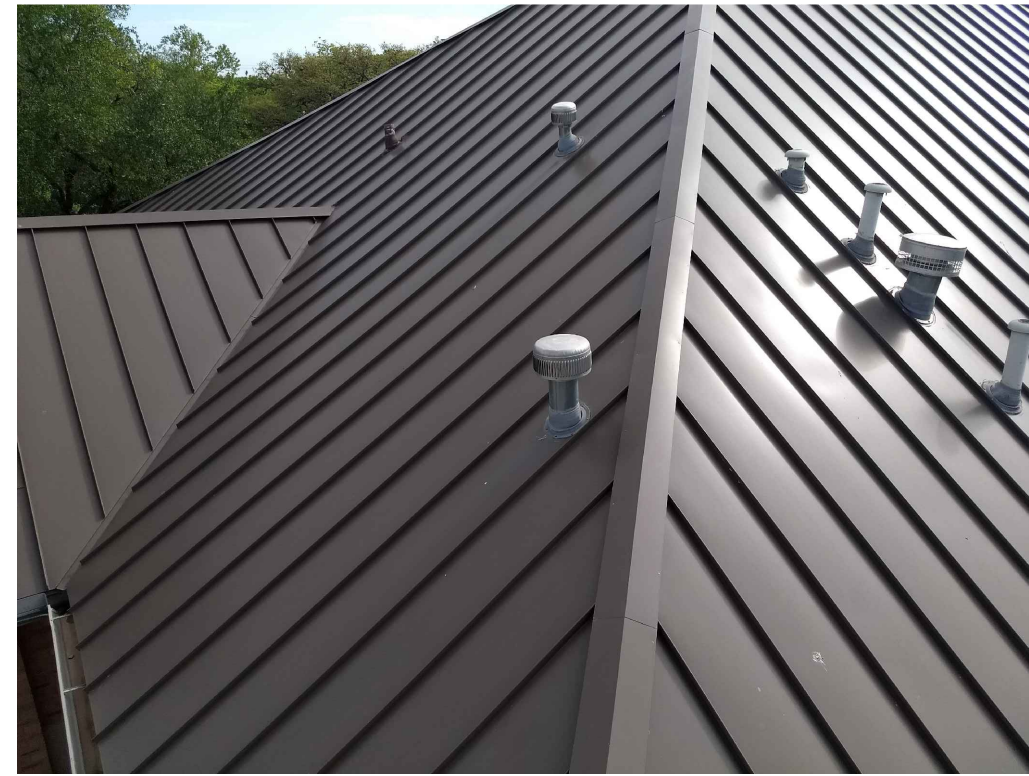
IMAGE 1: ROOF: VENT AND PLUMBING PENETRATIONS THROUGH THE METAL ROOF WERE IN FUNCTIONAL CONDITION WITH THE EXCEPTION OF THE VENT PIPE ASSOCIATED WITH THE WATER HEATER AND INTERIOR LEAK. EXPOSED FASTENERS AND TEMPORARY SEALANT AT THE HOT WATER VENT STACK PENETRATION.

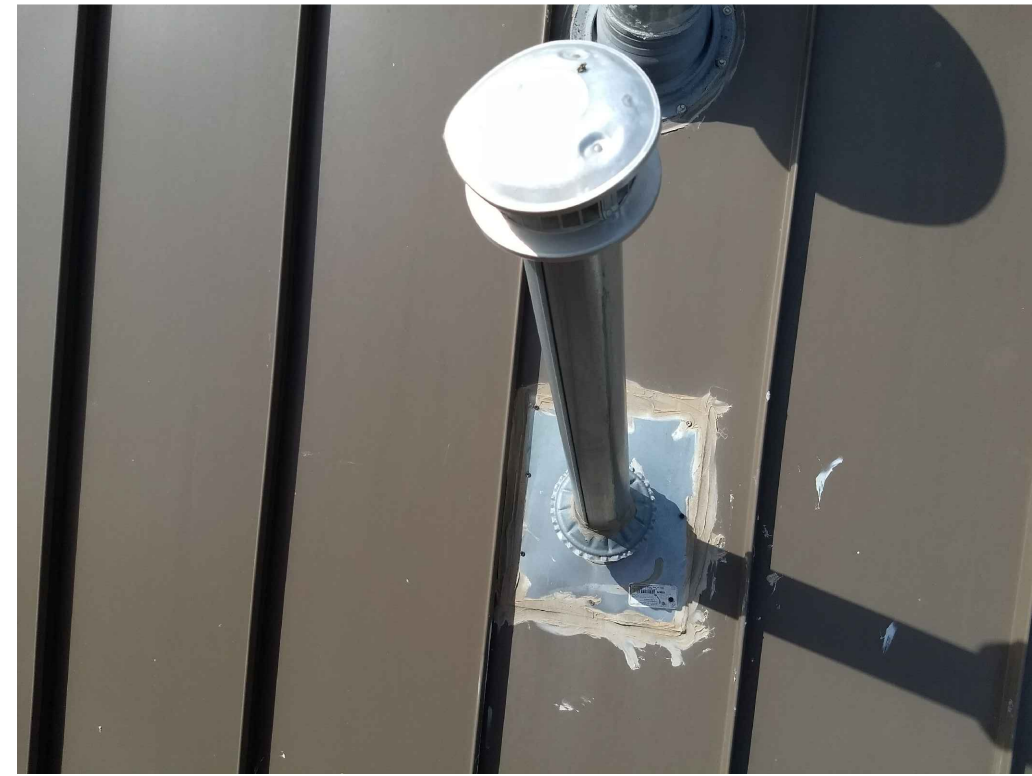
IMAGE 2: ROOF: VENT AND PLUMBING PENETRATIONS THROUGH THE METAL ROOF WERE IN FUNCTIONAL CONDITION WITH THE EXCEPTION OF THE VENT PIPE ASSOCIATED WITH THE WATER HEATER AND INTERIOR LEAK. EXPOSED FASTENERS AND TEMPORARY SEALANT AT THE HOT WATER VENT STACK PENETRATION.

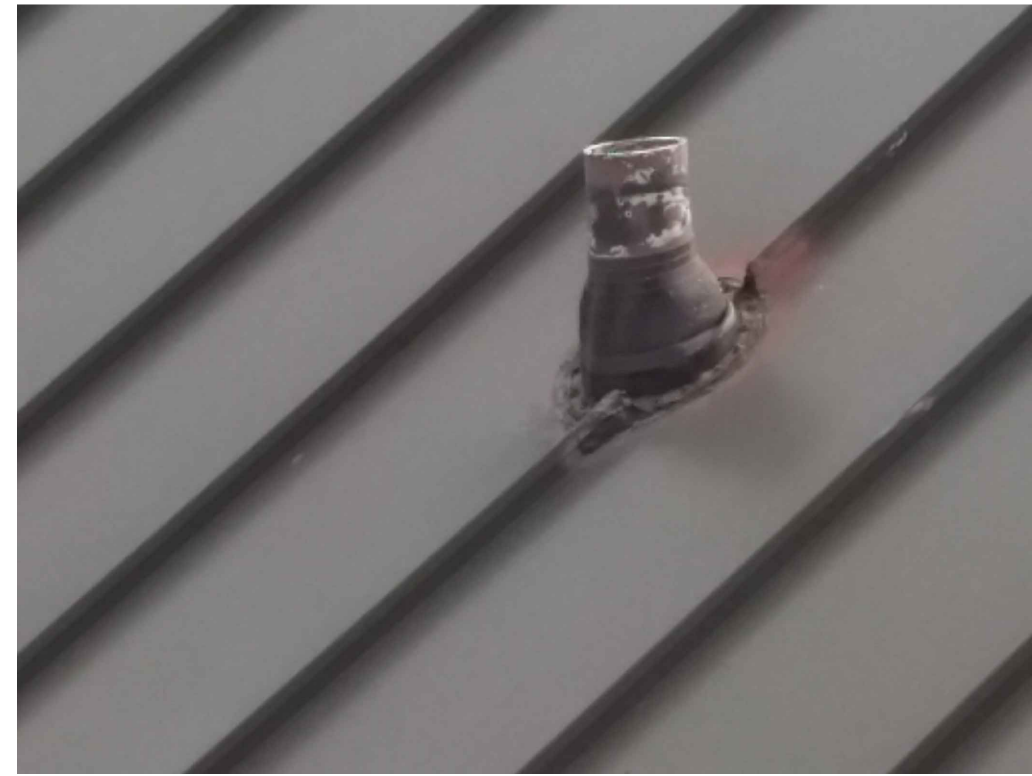
IMAGE 3: ROOF: EXISTING SEALANT IS TEMPORARY SEALANT.

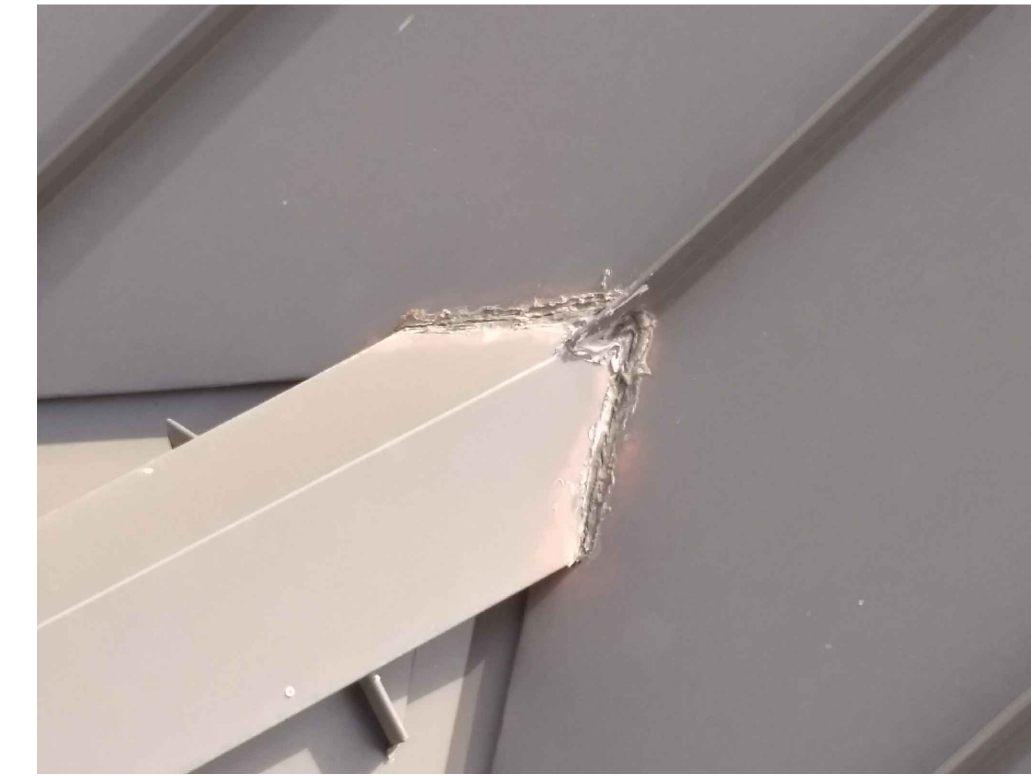
IMAGE 4: ROOF: DETERIORATING SEALANT WAS NOTED AT THE INTERSECTION OF THE METAL ROOF PANELS TO DORMERS. THE INTERSECTION OF DORMER ROOF TO THE METAL ROOF PANELS DOES NOT HAVE A FLASHING AND INSTEAD RELIES ON SEALANT TO MAINTAIN A WATER TIGHT INTERSECTION.

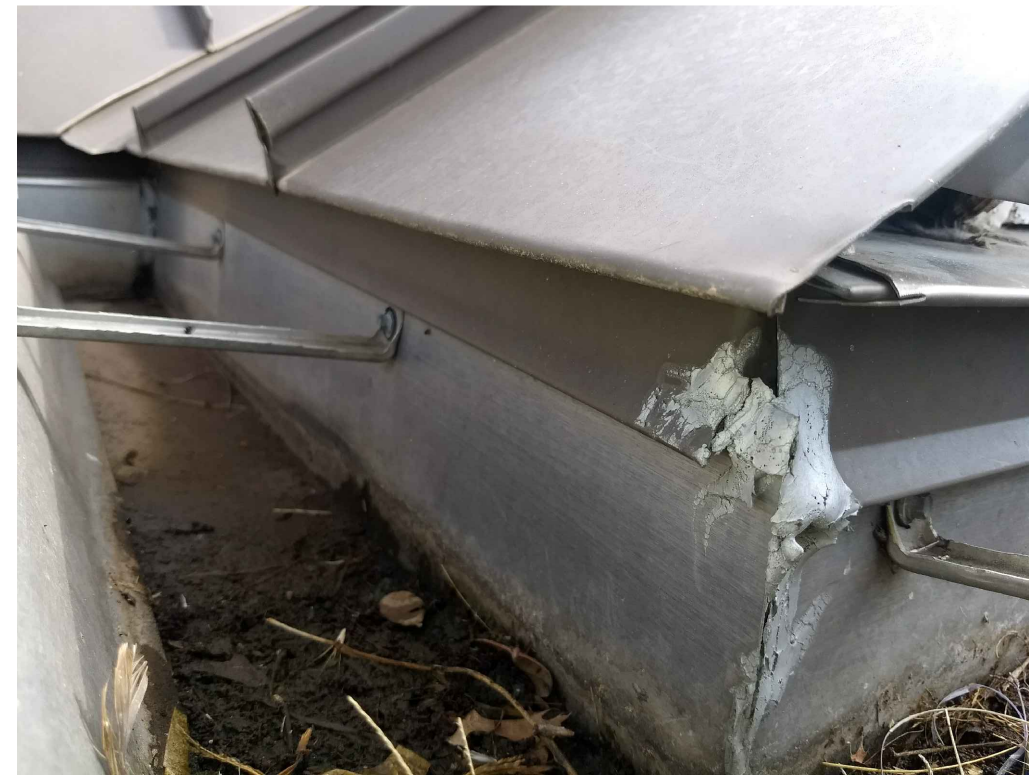
IMAGE 5: GUTTERS: GUTTER ASSEMBLY HAS LOST SECUREMENT TO THE WOOD FASCIA. DETERIORATED WOOD FASCIA AND COMPONENTS ARE NO LONGER PROVIDING SECURE AND SAFE SUBSTRATE FOR THE ATTCHMENT OF GUTTER ASSEMBLY.

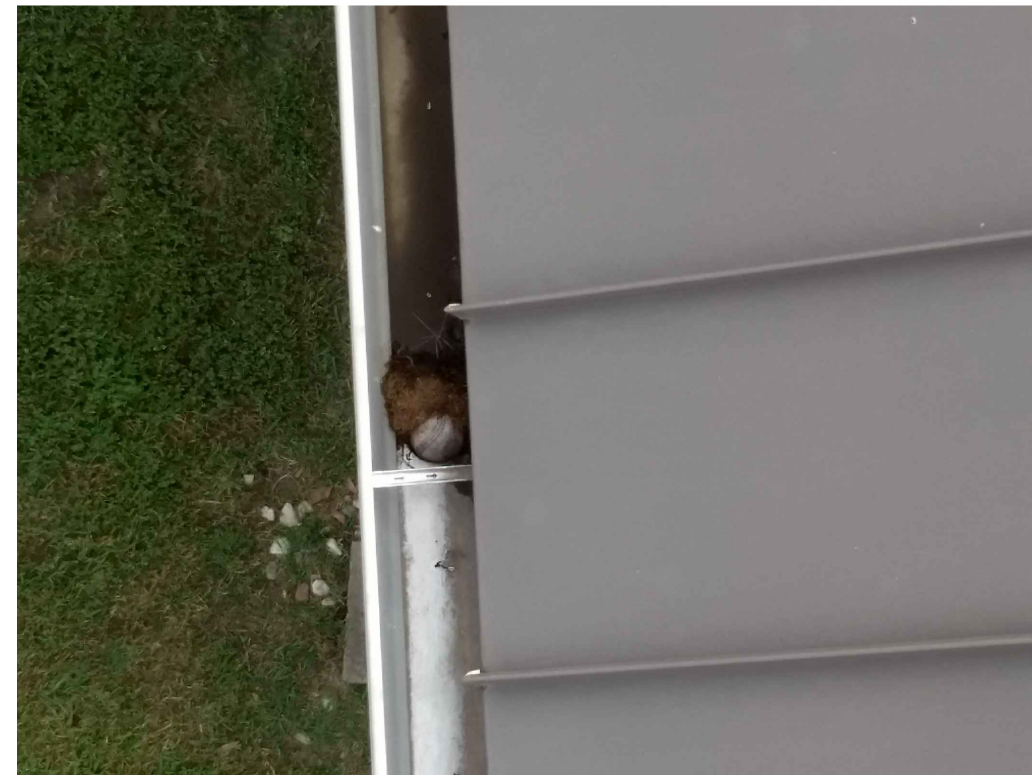
IMAGE 6: GUTTERS: EXCESSIVE DEBRIS IN THE GUTTER OBSTRUCTING GUTTERS AND DOWNSPOUTS MAY CONTRIBUTE TO GUTTER OVERFLOW.

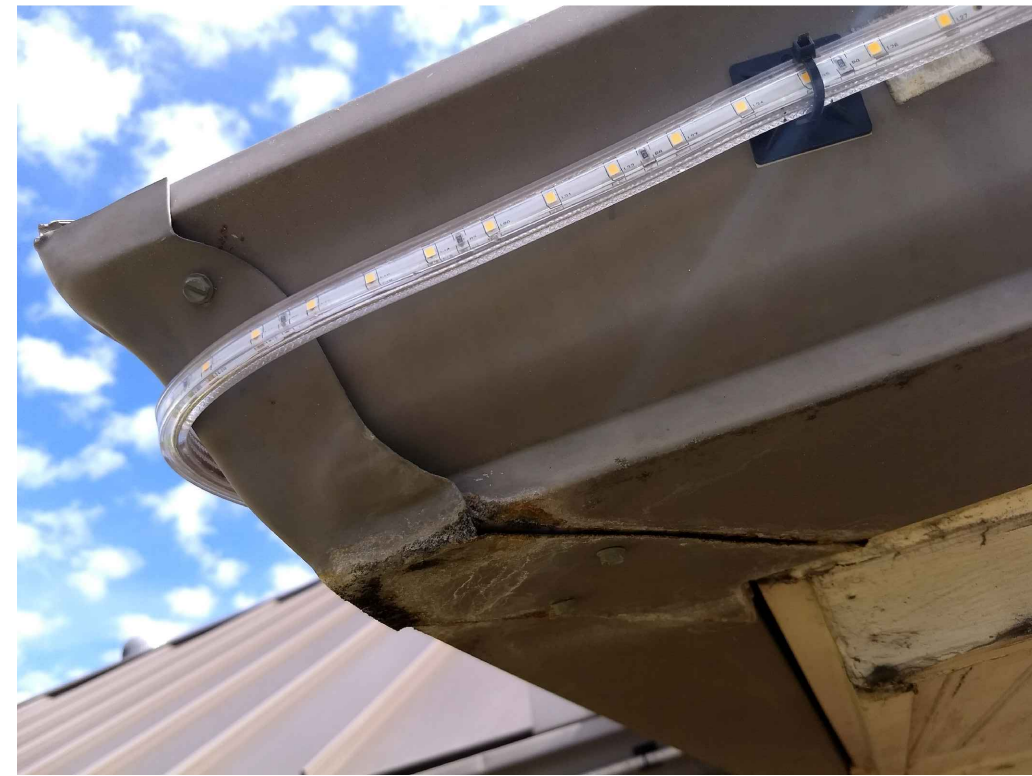
IMAGE 7: GUTTERS: DETERIORATED METAL AT SEAMS OF GUTTER.

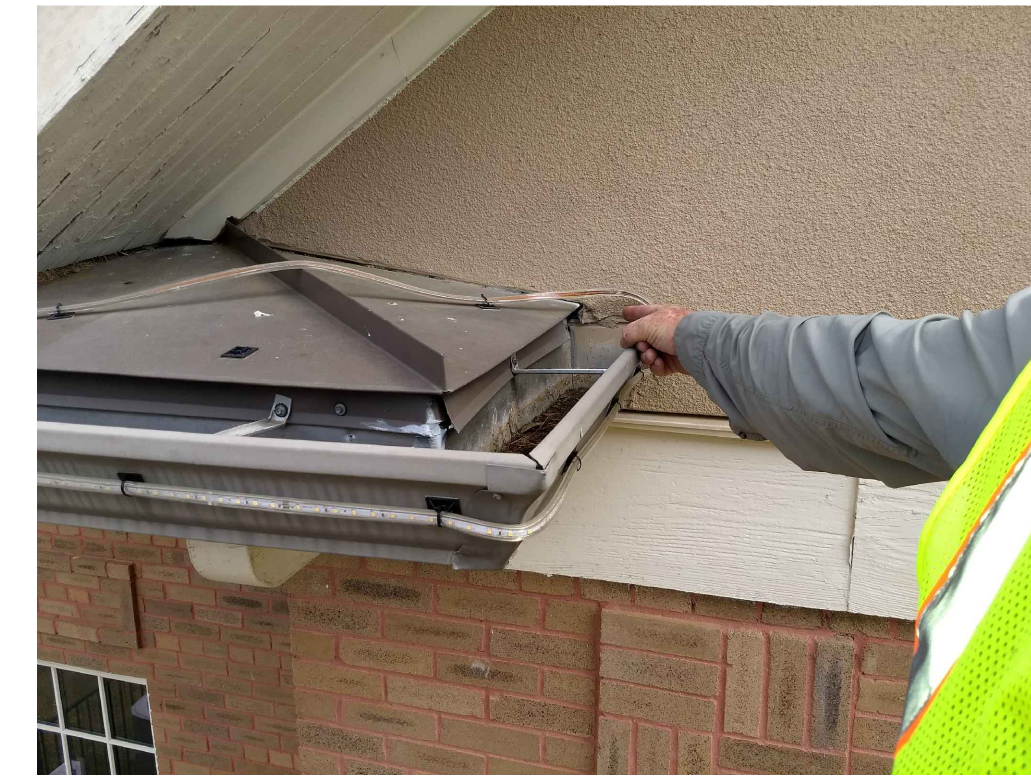
IMAGE 8: STUCCO: HOLE IN STUCCO AT TRANSITION FROM METAL ROOF TO STUCCO ALLOWS WATER INTO EXTERIOR WALL CONSTRUCTION.

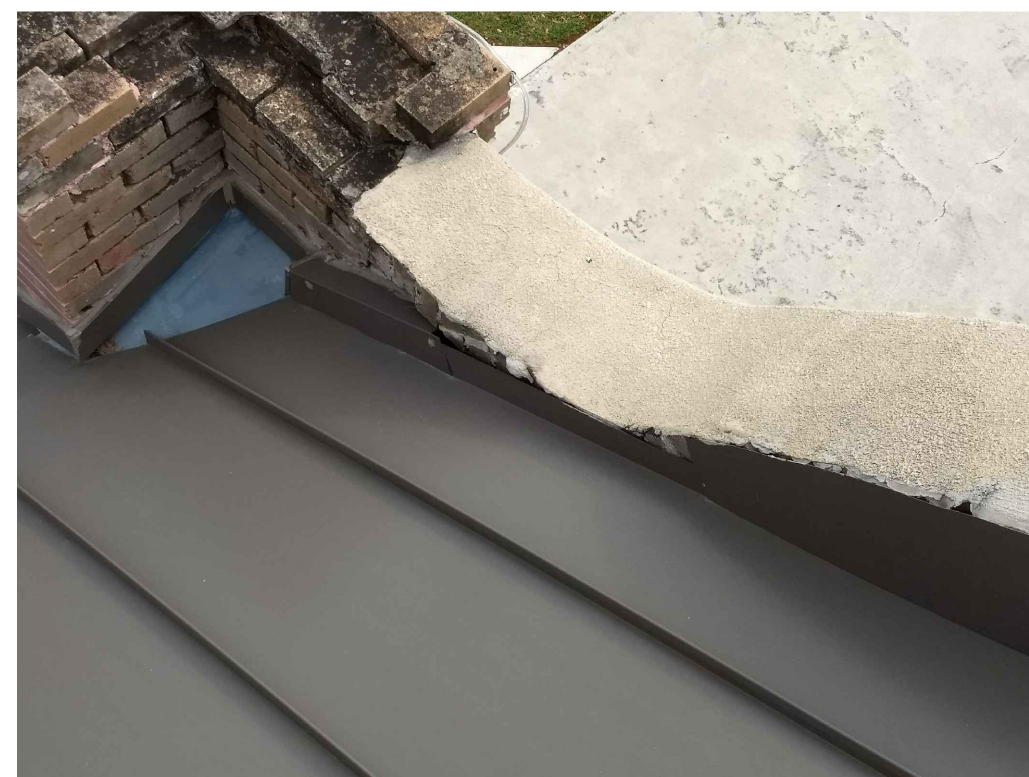
IMAGE 9: ARCH OVER ENTRYWAYS: SEVERAL AREAS AT ALL LOCATIONS SHOW DETERIORATION AT THE EDGE OF THE CEMENT WASH AND OPENINGS AT THE INTERSECTION OF THE SHEET METAL FLASHINGS. ALSO, SIGNIFICANT DETERIORATION OF THE ADJOINING MASONRY, ALLOWING AN ENTRY POINT FOR MOISTURE.

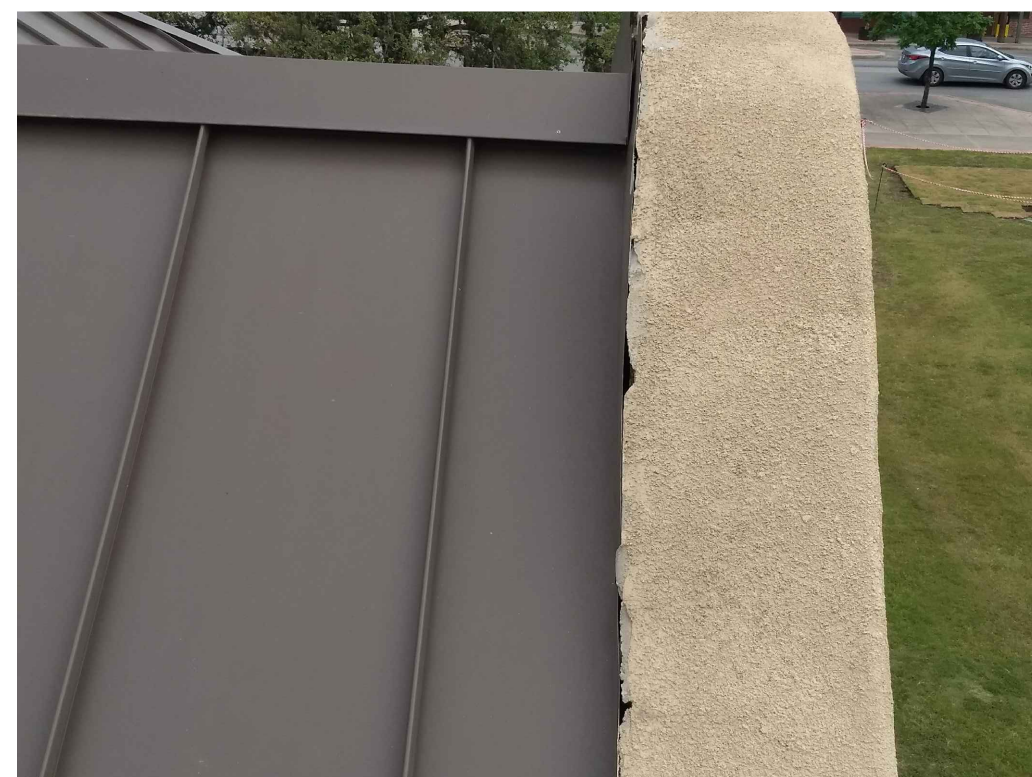
IMAGE 10: ARCH OVER ENTRYWAYS: SEVERAL AREAS AT ALL LOCATIONS SHOW DETERIORATION AT THE EDGE OF THE CEMENT WASH AND OPENINGS AT THE INTERSECTION OF THE SHEET METAL FLASHINGS. ALSO, SIGNIFICANT DETERIORATION OF THE ADJOINING MASONRY, ALLOWING AN ENTRY POINT FOR MOISTURE.
