# KRUG ACTIVITY CENTER

## EXTERIOR HISTORIC REPAIRS

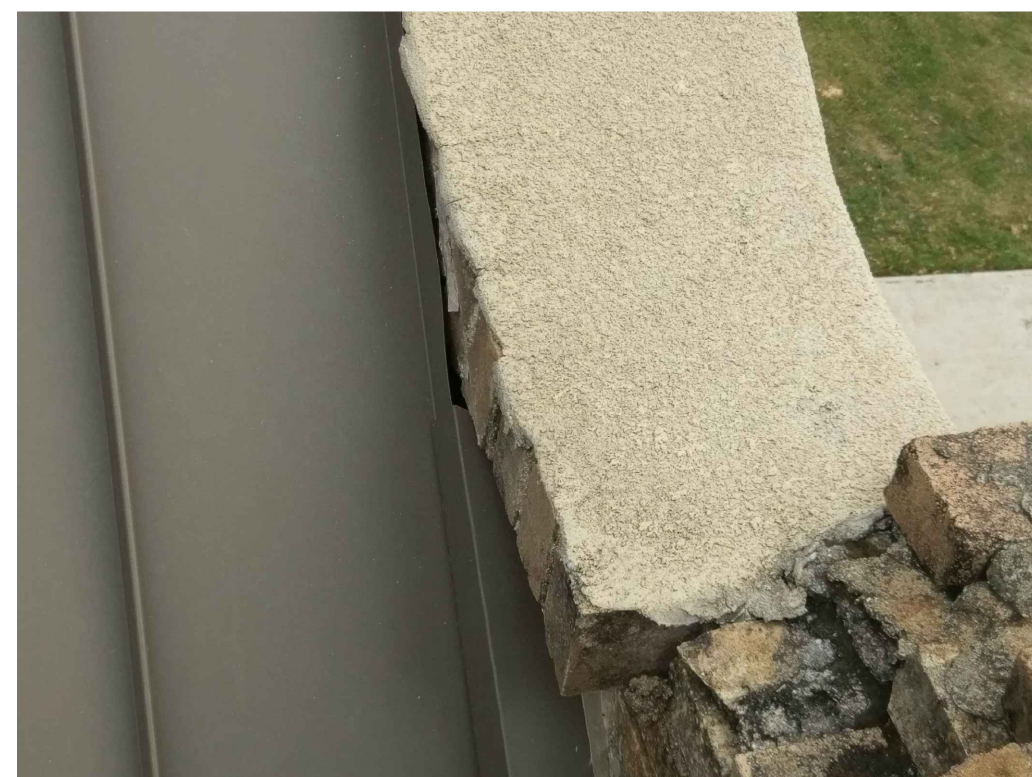
IMAGE 11: ARCH OVER ENTRYWAYS: SEVERAL AREAS AT ALL LOCATIONS SHOW DETERIORATION AT THE EDGE OF THE CEMENT WASH AND OPENINGS AT THE INTERSECTION OF THE SHEET METAL FLASHINGS. ALSO, SIGNIFICANT DETERIORATION OF THE ADJOINING MASONRY, ALLOWING AN ENTRY POINT FOR MOISTURE.

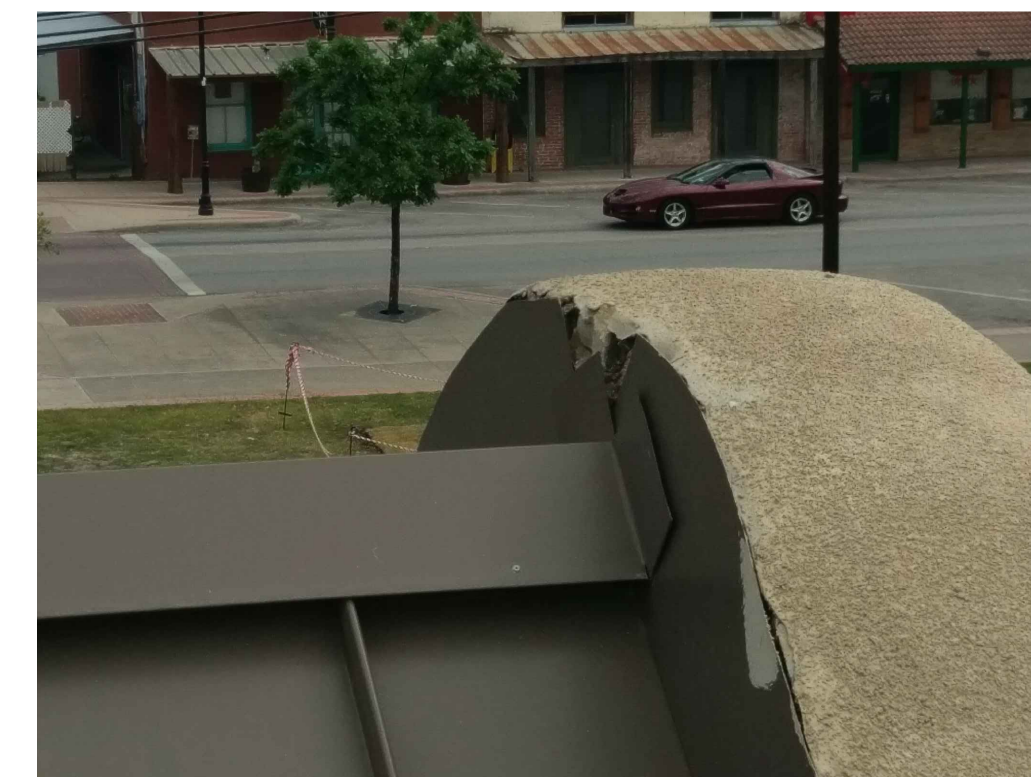
IMAGE 12: ARCH OVER ENTRYWAYS: SEVERAL AREAS AT ALL LOCATIONS SHOW DETERIORATION AT THE EDGE OF THE CEMENT WASH AND OPENINGS AT THE INTERSECTION OF THE SHEET METAL FLASHINGS. ALSO, SIGNIFICANT DETERIORATION OF THE ADJOINING MASONRY, ALLOWING AN ENTRY POINT FOR MOISTURE.

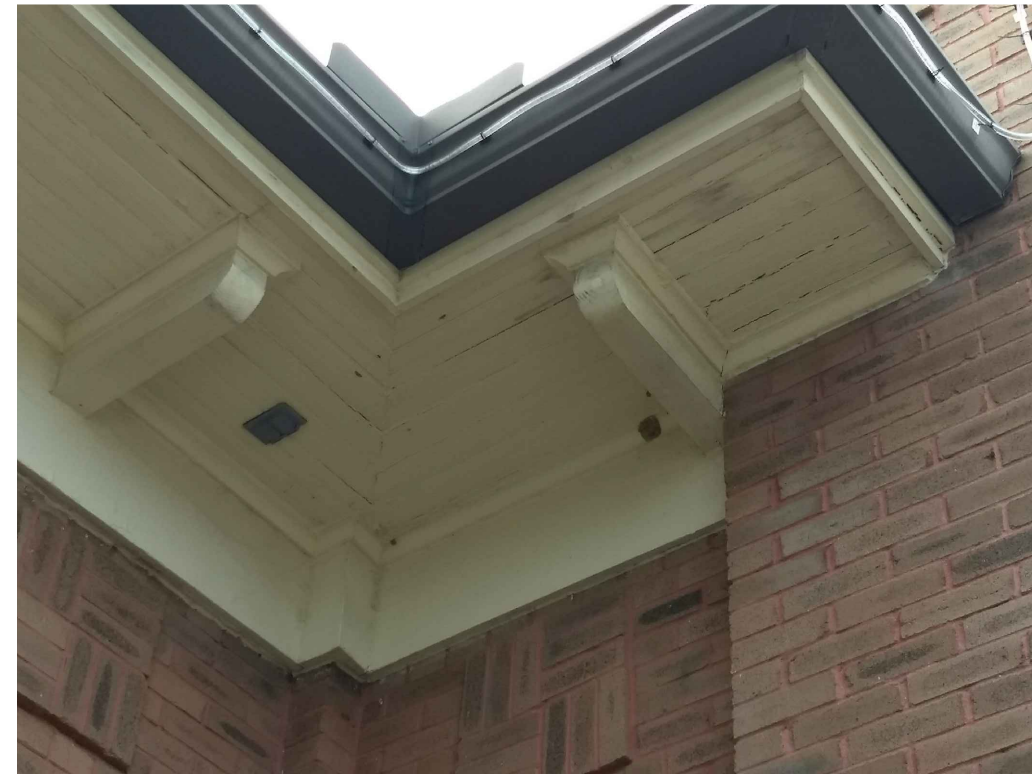
IMAGE 2: WOOD: SOFFITS SAGGING AND PULLING AWAY FROM THE STRUCTURE. DETERIORATION AT THE TOP OF THE ENTRANCE WAY MASONRY IS RESULTING IN WATER ENTRY IN THESE AREAS, CONTRIBUTING TO VISIBLE DAMAGE TO WOOD FASCIA AND SOFFIT ASSEMBLIES AND LIKELY DAMAGE TO UNDERLYING WOOD DECK AND SUPPORT MEMBERS.

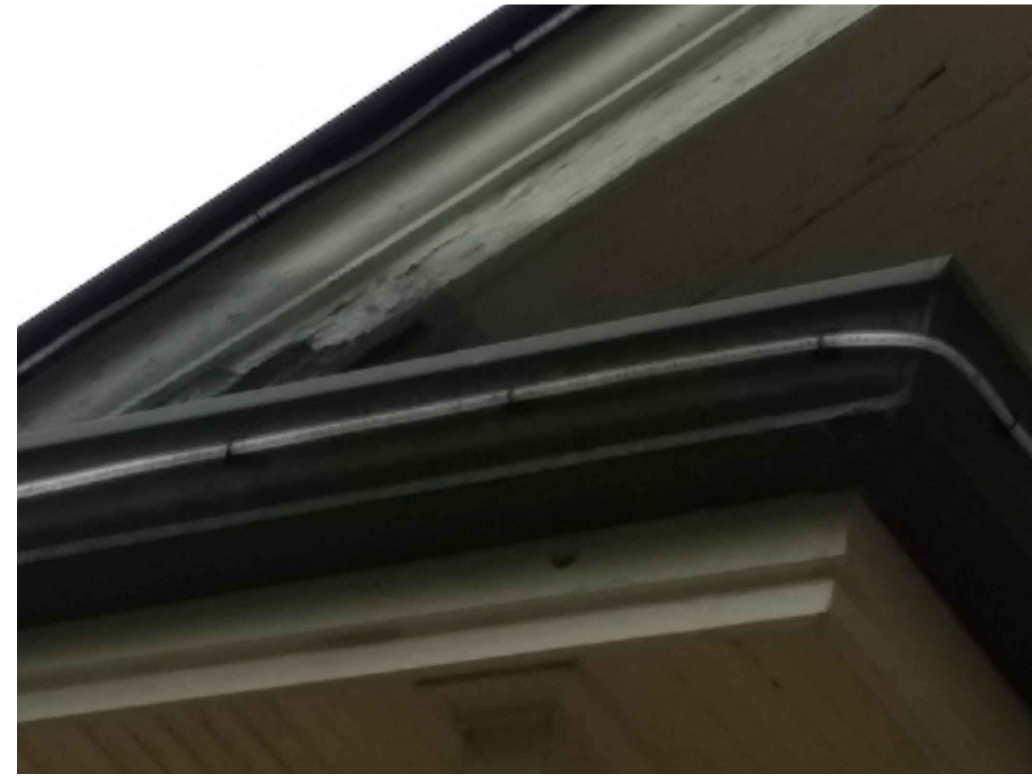
IMAGE 2: WOOD: SOFFITS SAGGING AND PULLING AWAY FROM THE STRUCTURE. DETERIORATION AT THE TOP OF THE ENTRANCE WAY MASONRY IS RESULTING IN WATER ENTRY IN THESE AREAS, CONTRIBUTING TO VISIBLE DAMAGE TO WOOD FASCIA AND SOFFIT ASSEMBLIES AND LIKELY DAMAGE TO UNDERLYING WOOD DECK AND SUPPORT MEMBERS.

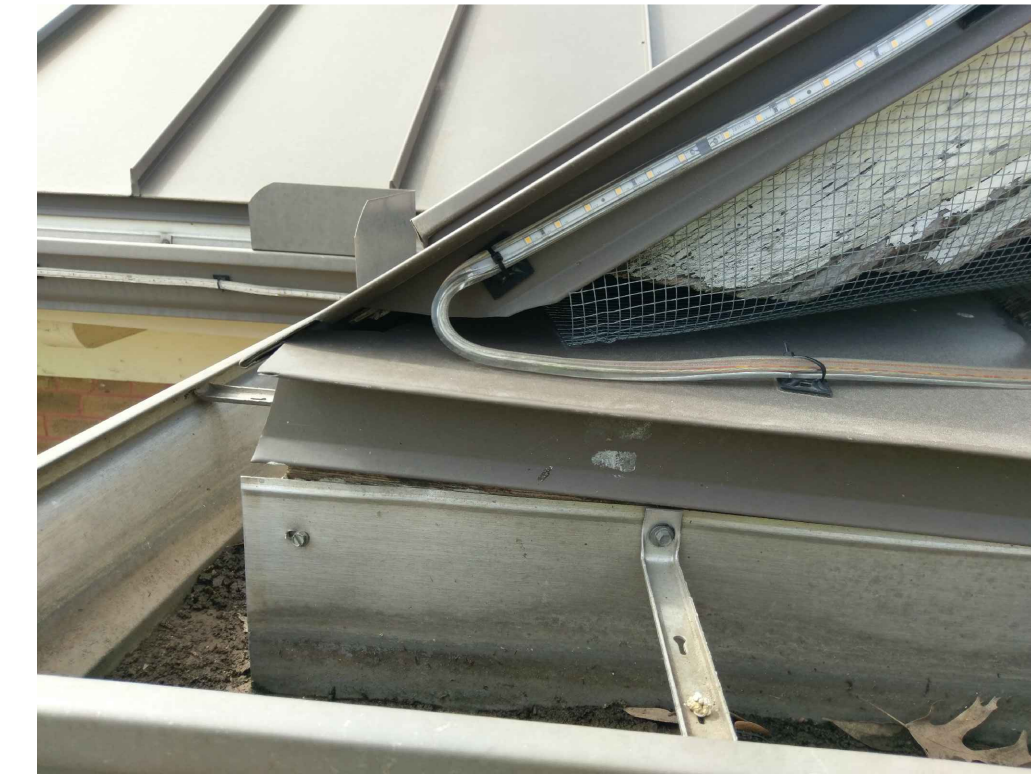
IMAGE 4: WOOD: WOOD FASCIA AT THE RAKE OF THE ROOF APPEARS TO BE THE RESULT OF FAILING PAINT AND AGED, DETERIORATED WOOD FASCIA. DETERIORATED AND WEAKENED WOOD ABOVE THE SOFFITS PROVIDES AN ACCESSIBLE ENTRY POINT FOR RODENTS, INSECTS AND BIRDS. ALSO, DETERIORATED WOOD FASCIA HAS RESULTED IN LOCALIZED SEPARATION OF THE GUTTER ASSEMBLY.

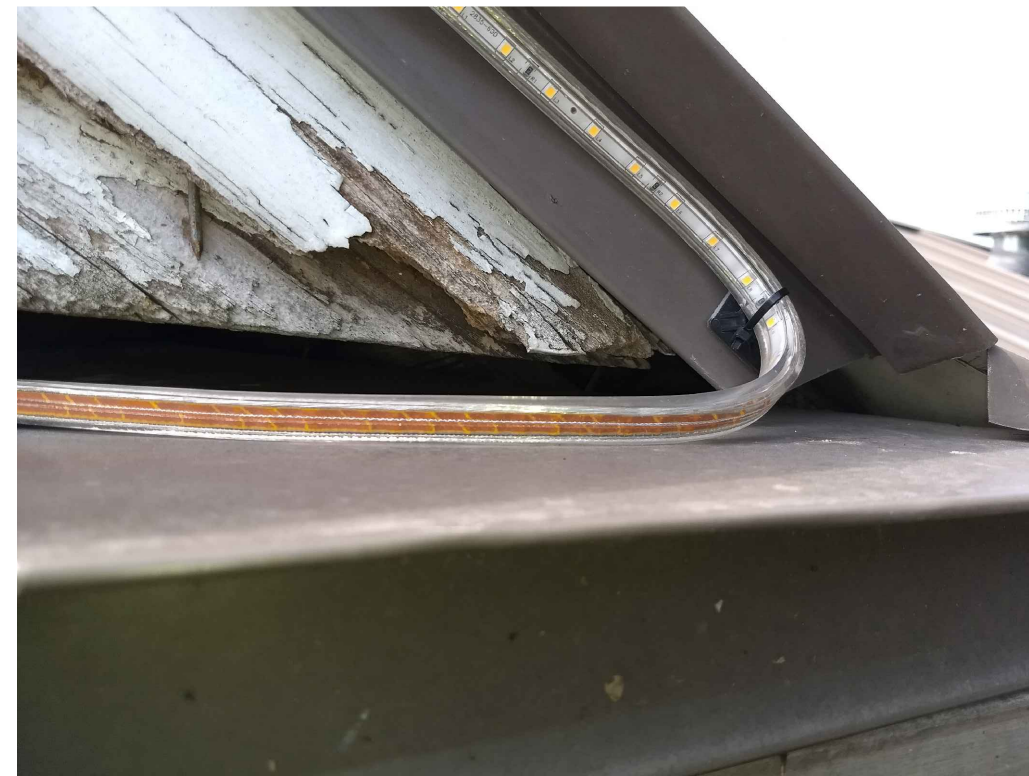
IMAGE 5: WOOD: SOFFITS SAGGING AND PULLING AWAY FROM THE STRUCTURE. DETERIORATION OF WOOD COMPONENTS AND STRUCTURAL THERMAL MOVEMENT HAVE RESULTED IN LOSS OF POSITIVE SECUREMENT OF THESE SOFFIT ASSEMBLIES WHICH IS A SAFETY CONCERN.

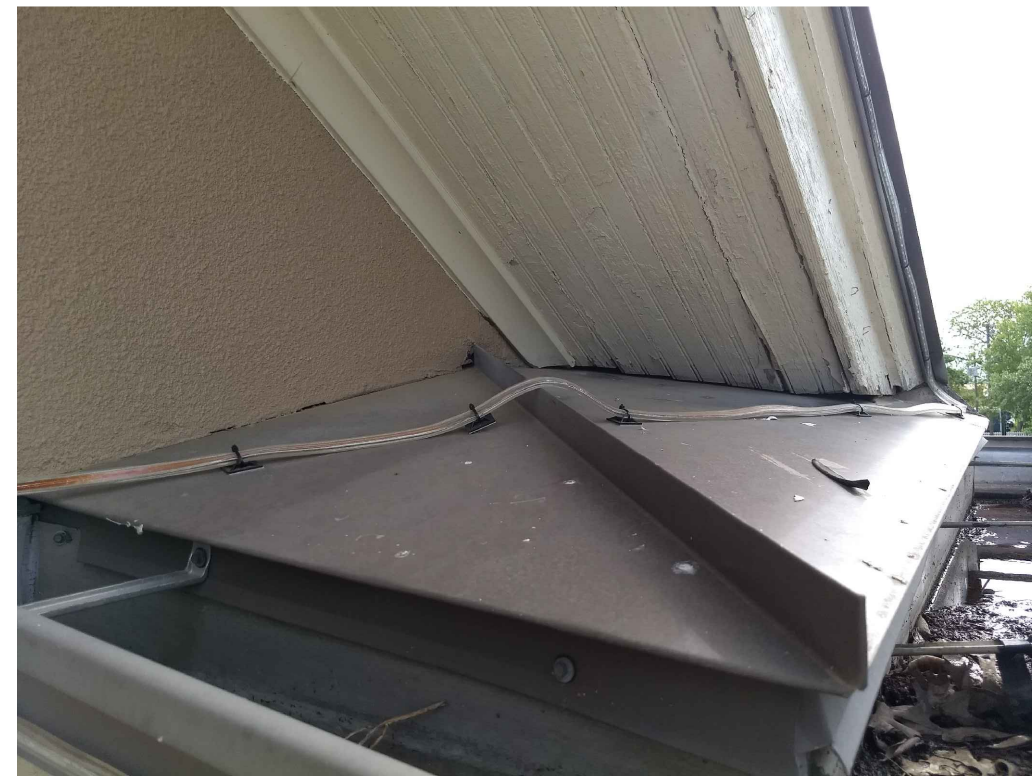
IMAGE 6: WOOD: SOFFITS SAGGING AND PULLING AWAY FROM THE STRUCTURE. DETERIORATION OF WOOD COMPONENTS AND STRUCTURAL THERMAL MOVEMENT HAVE RESULTED IN LOSS OF POSITIVE SECUREMENT OF THESE SOFFIT ASSEMBLIES WHICH IS A SAFETY CONCERN.

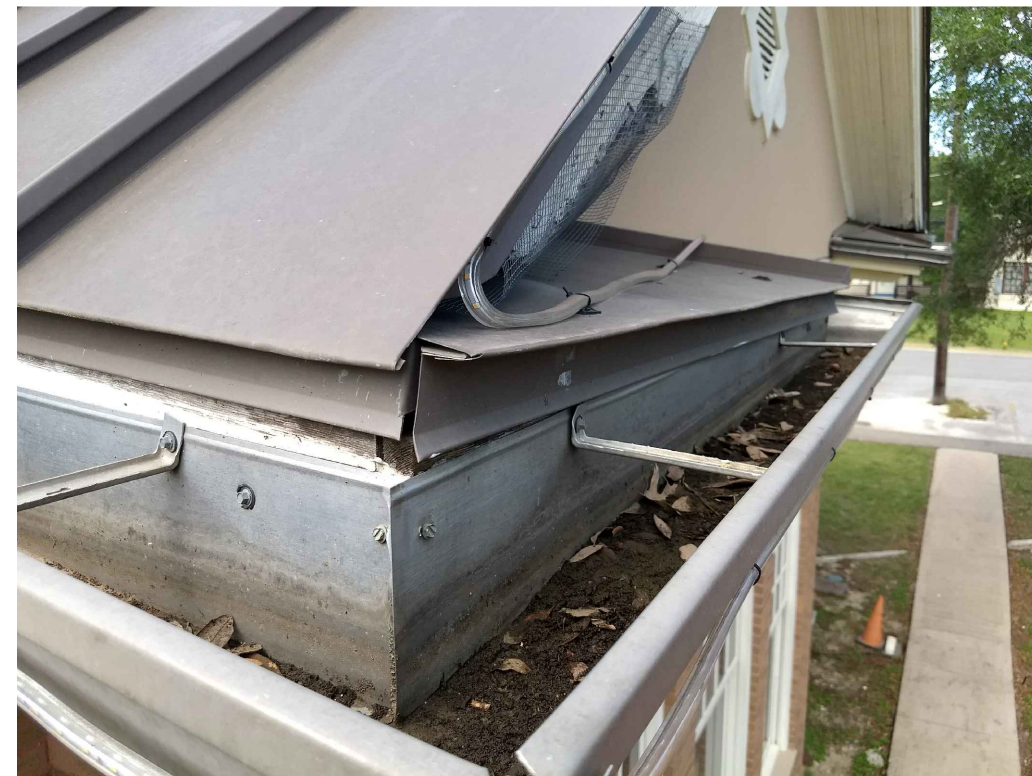
IMAGE 7: WOOD: SOFFITS SAGGING AND PULLING AWAY FROM THE STRUCTURE. GUTTERS WATER GETTING BACKED UP IN THE GUTTER DUE TO DEBRIS BLOCKING THE DOWNSPOUTS IS BACKING INTO THE OVERHANG STRUCTURE IS BELIEVED TO BE CAUSING DAMAGE TO FASCIA AND SOFFITS.

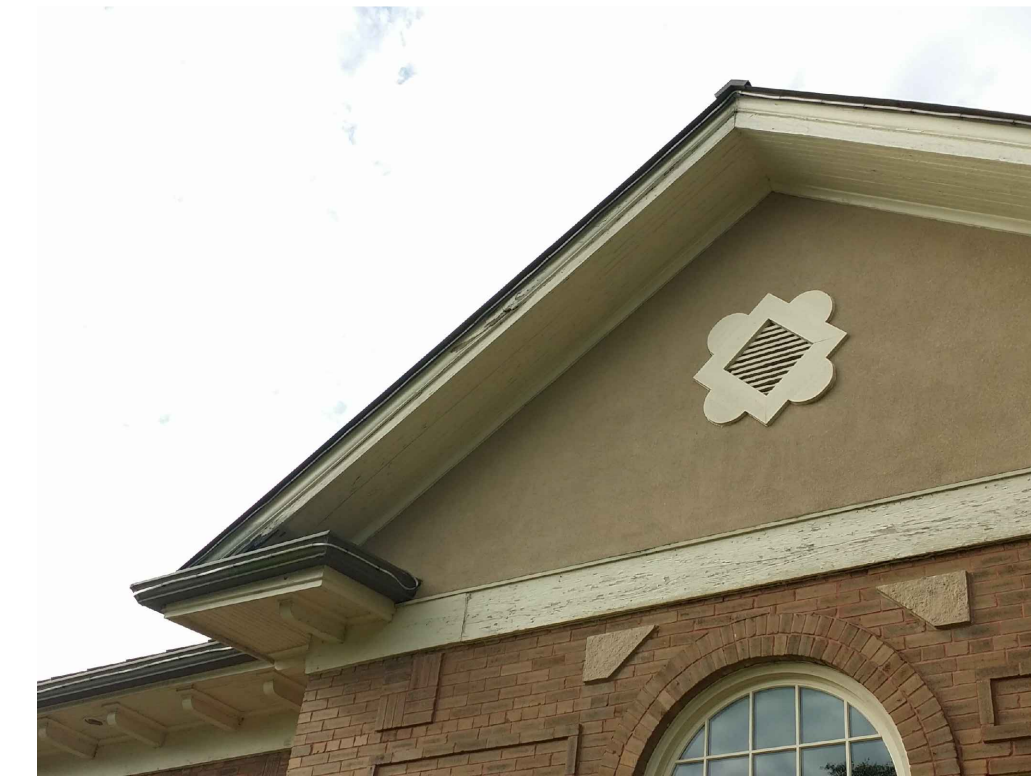
IMAGE 8: WOOD: WOOD SOFFIT AND FASCIA DETERIORATION SEAM INCONSISTENT WITH THE RECENT METAL ROOF INSTALLATION, INDICATING THE EXISTING SOFFITS AND FASCIA WERE NOT REPLACED RECENTLY BUT LIKELY REPAINTED. IN ISOLATED INSTANCES FAILURE DUE TO THE GUTTER SEAMS HAS CONTRIBUTED TO THE DETERIORATION.

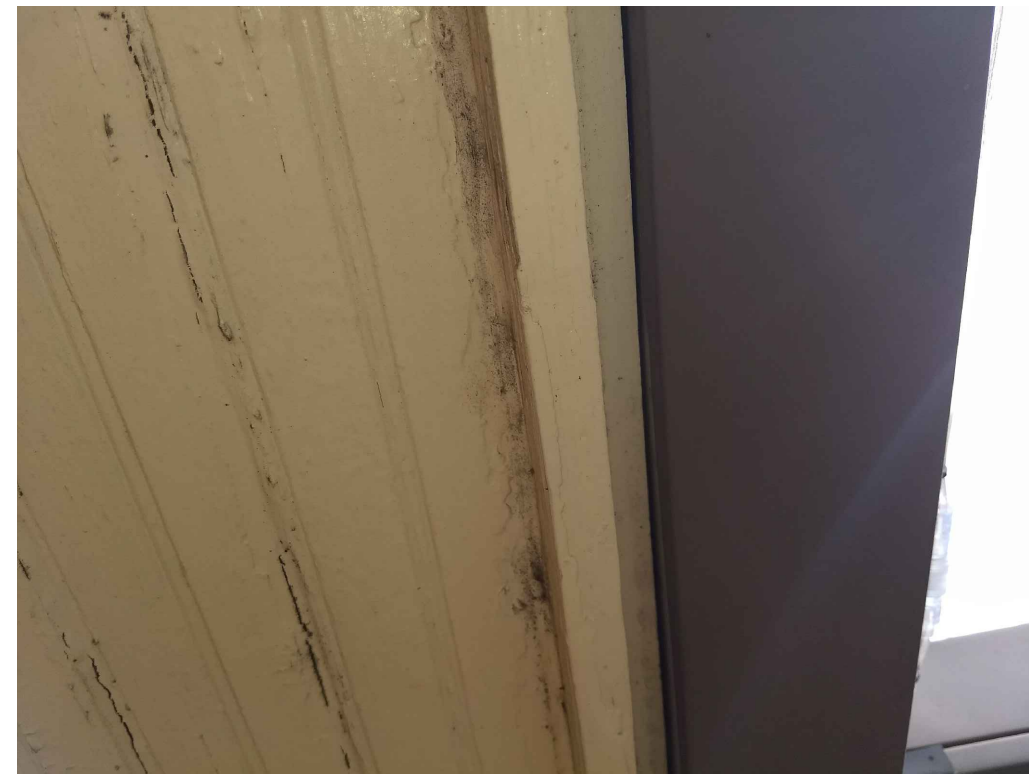
IMAGE 9: WOOD: SOFFITS SAGGING AND PULLING AWAY FROM THE STRUCTURE. DEBRIS OBSTRUCTING THE GUTTER AND DOWNSPOUTS MAY CONTRIBUTE TO GUTTER OVERFLOW DURING RAIN EVENTS.

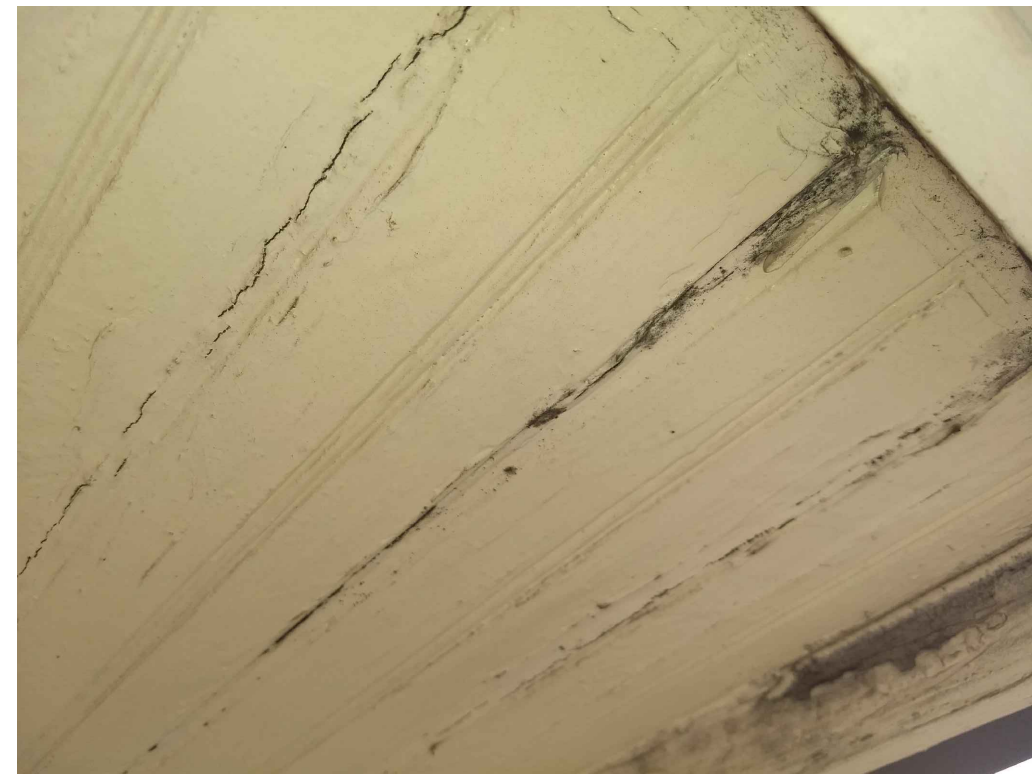
IMAGE 10: WOOD SOFFIT AND FASCIA DETERIORATION SEAM INCONSISTENT WITH THE RECENT METAL ROOF INSTALLATION, INDICATING THE EXISTING SOFFITS AND FASCIA WERE NOT REPLACED RECENTLY BUT LIKELY REPAINTED. IN ISOLATED INSTANCES FAILURE DUE TO THE GUTTER SEAMS HAS CONTRIBUTED TO THE DETERIORATION.

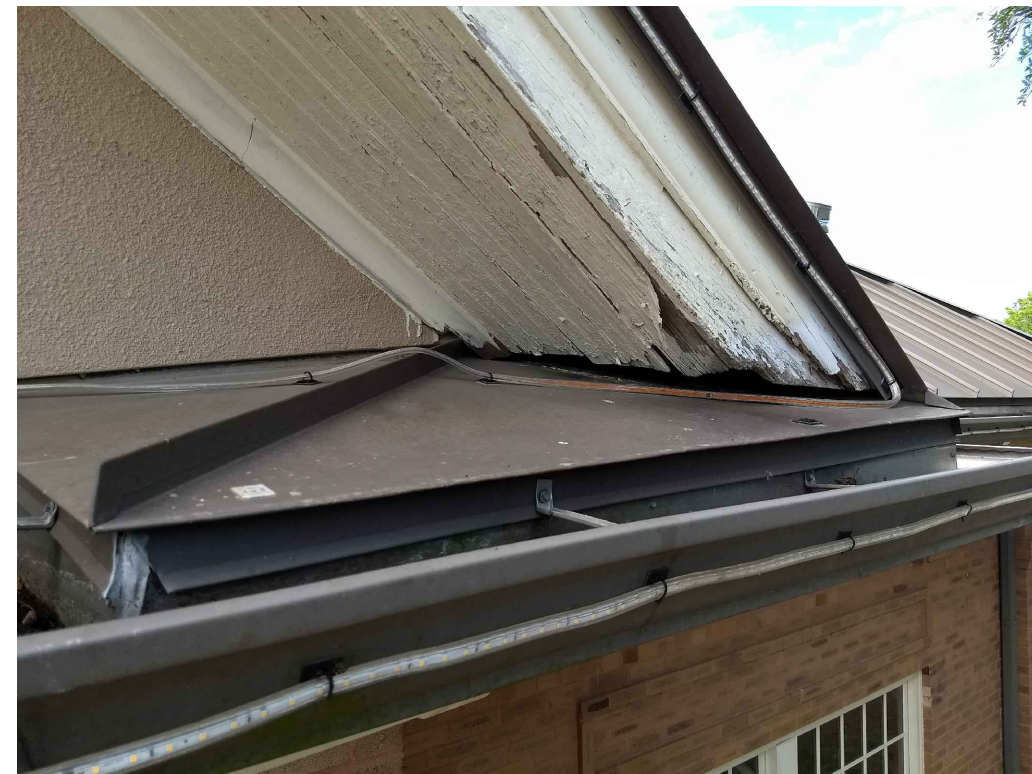
IMAGE 11: WOOD SOFFIT AND FASCIA DETERIORATION SEAM INCONSISTENT WITH THE RECENT METAL ROOF INSTALLATION, INDICATING THE EXISTING SOFFITS AND FASCIA WERE NOT REPLACED RECENTLY BUT LIKELY REPAINTED. IN ISOLATED INSTANCES FAILURE DUE TO THE GUTTER SEAMS HAS CONTRIBUTED TO THE DETERIORATION.

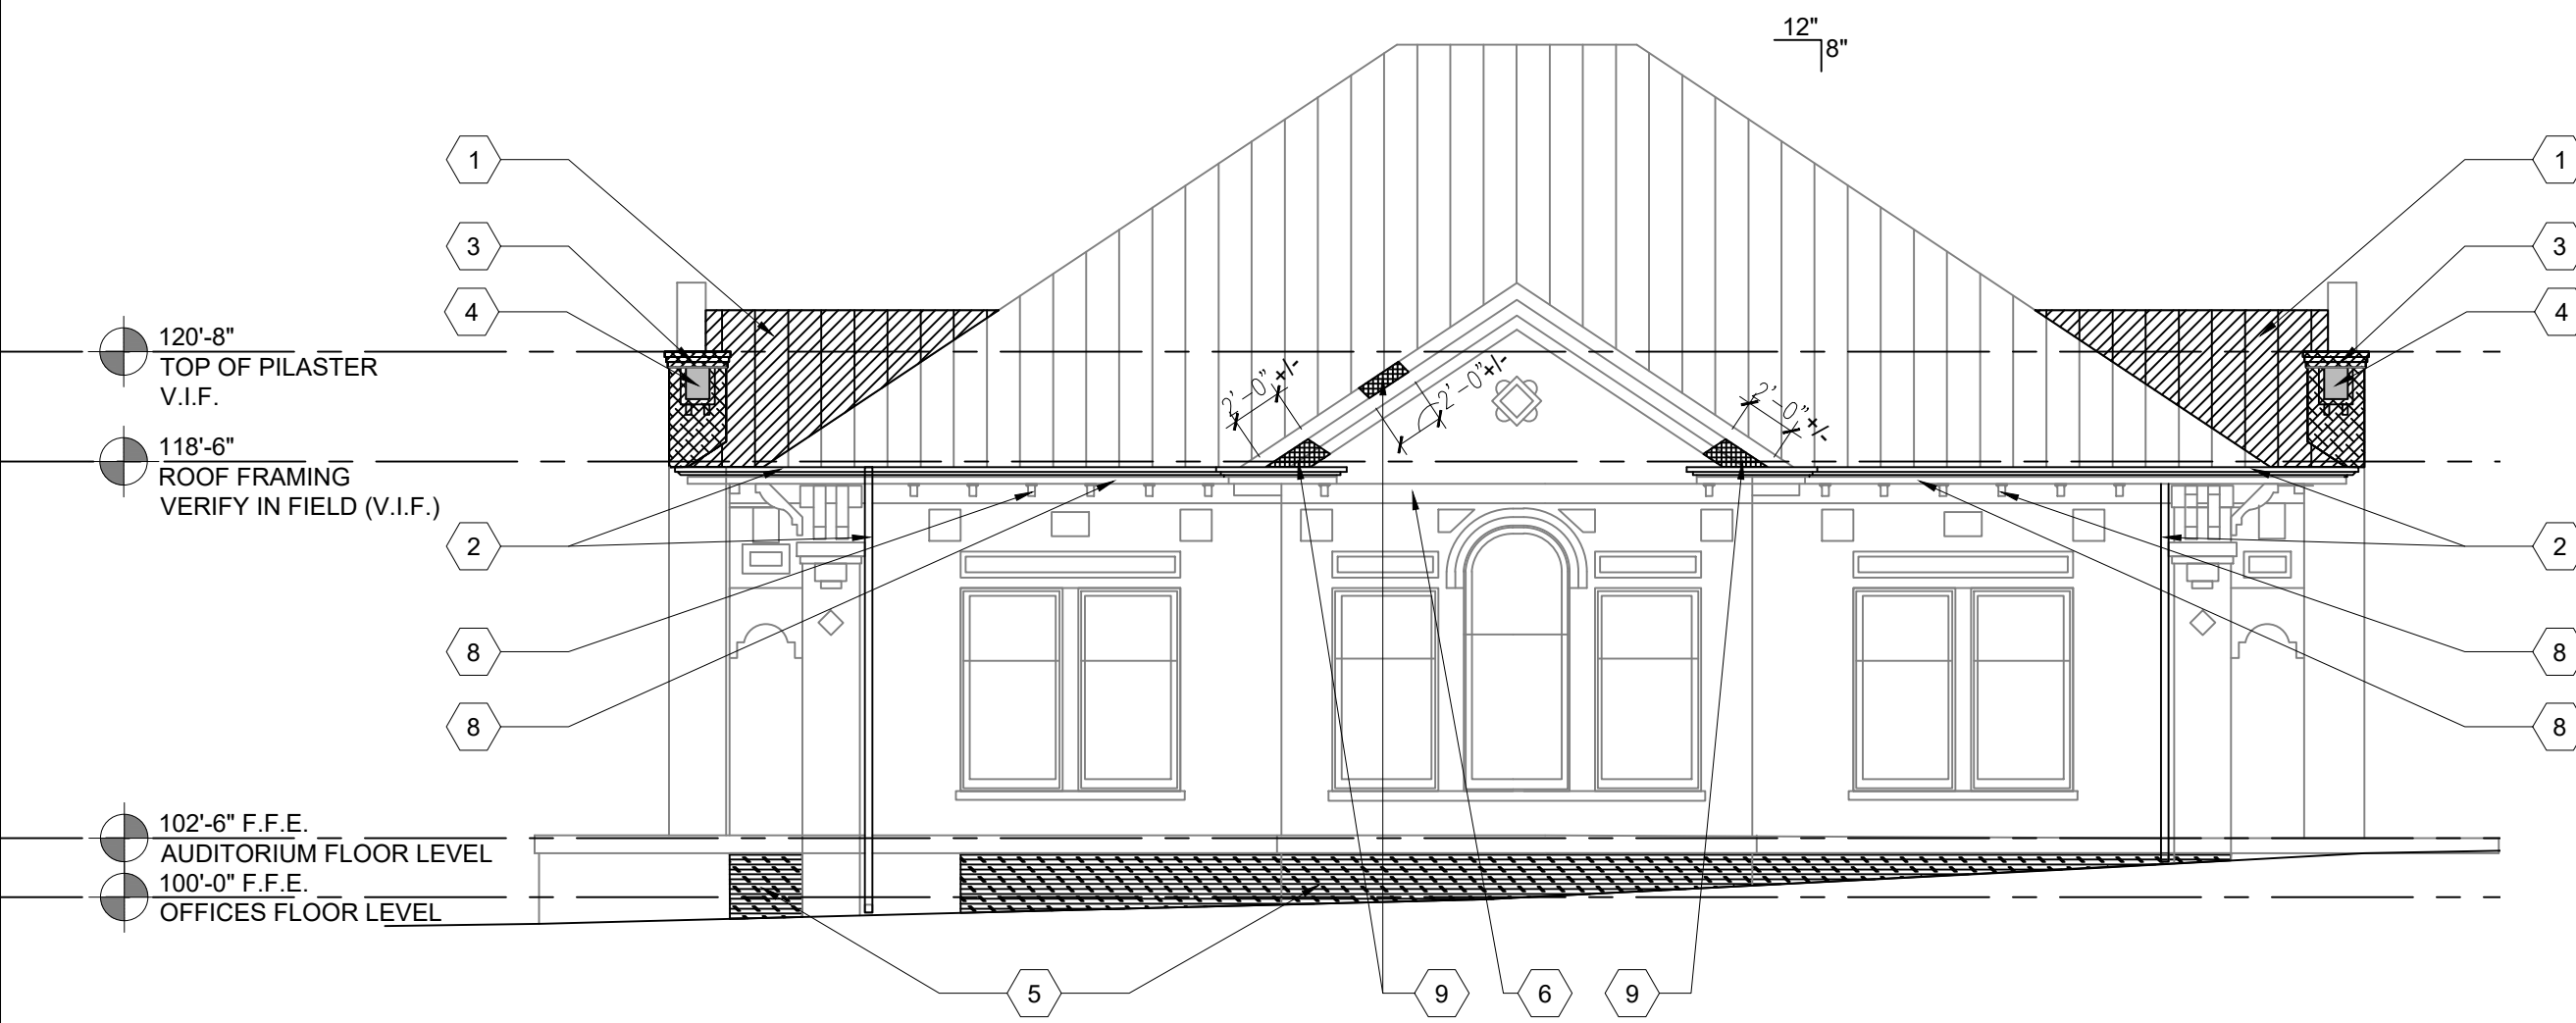
**1 DEMOLITION NORTH ELEVATION**  
Scale: 1/8" = 1' - 0"
